# Inspection Report

**PRO BUILD Inspections**

**The Scope of the Inspection:** This report Complies with Australian Standards AS 4349.1-2007. Inspection of Buildings Part 1: Pre- Purchase Inspections-Residential Buildings- Appendix "C"

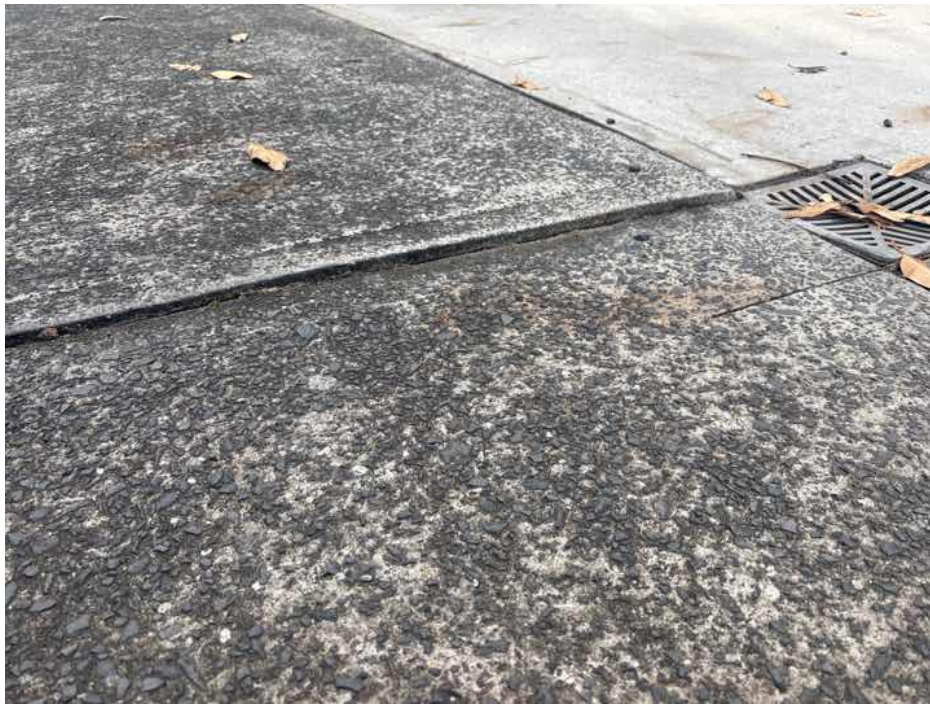
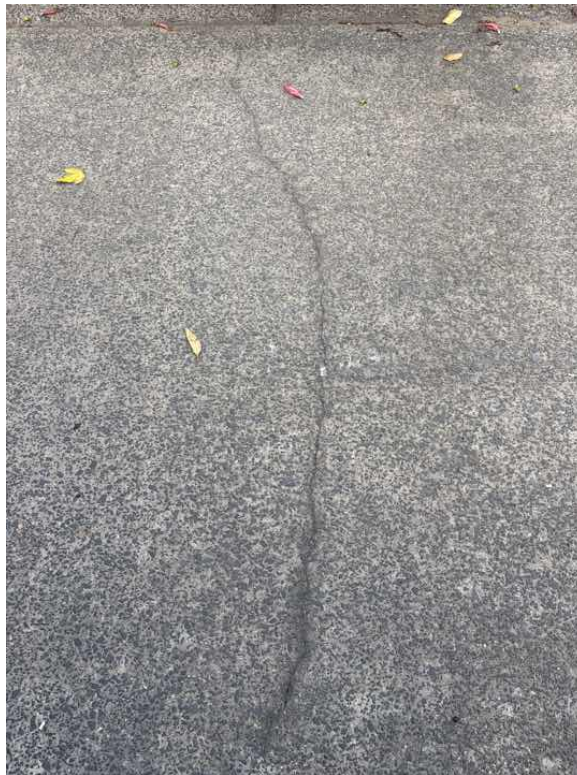
Common cracks were observed on the driveway. Whilst these cracks appeared to be typical at the time of inspection, we strongly recommend you monitor these cracks and if worsening occurs contact a concreter for further advice.

Surface raised and settled in some areas. This can cause water ponding. Relaying recommended.

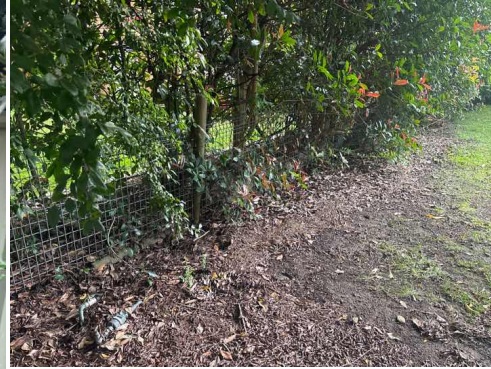
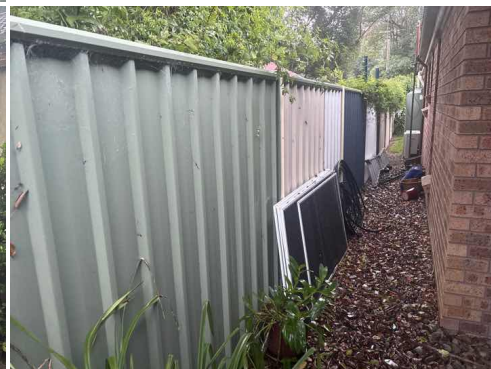
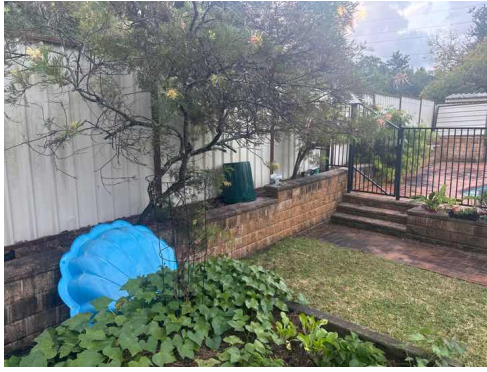
General age to fence components. General upkeep and maintenance required. A qualified fencing contractor should be engaged for repairs.

Impact damage noted to some fence panels.

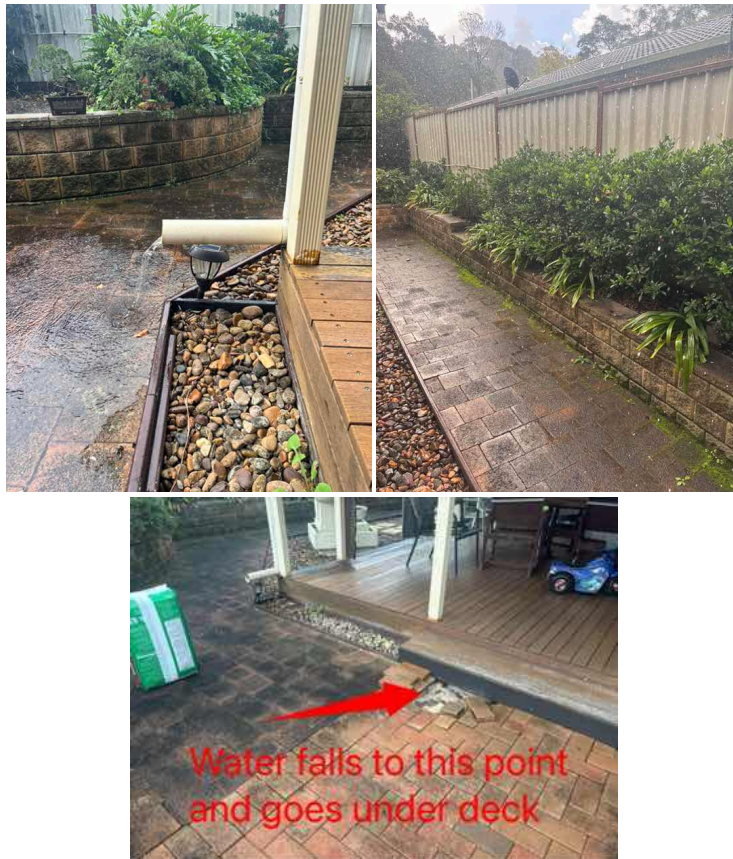
The ground levels along the perimeter walls at the rear of the home did not appear to fall away from the property walls sufficiently due to the natural landscape and contour. This will need to be assessed during a period of rainfall and if surface water appears to be entering the sub floor if applicable or ponding against the perimeter walls, engage a plumber or landscaper to assess and rectify as required. All drains should be regularly checked by a plumber and kept clean of debris to allow surface water to be carried away from the dwelling.

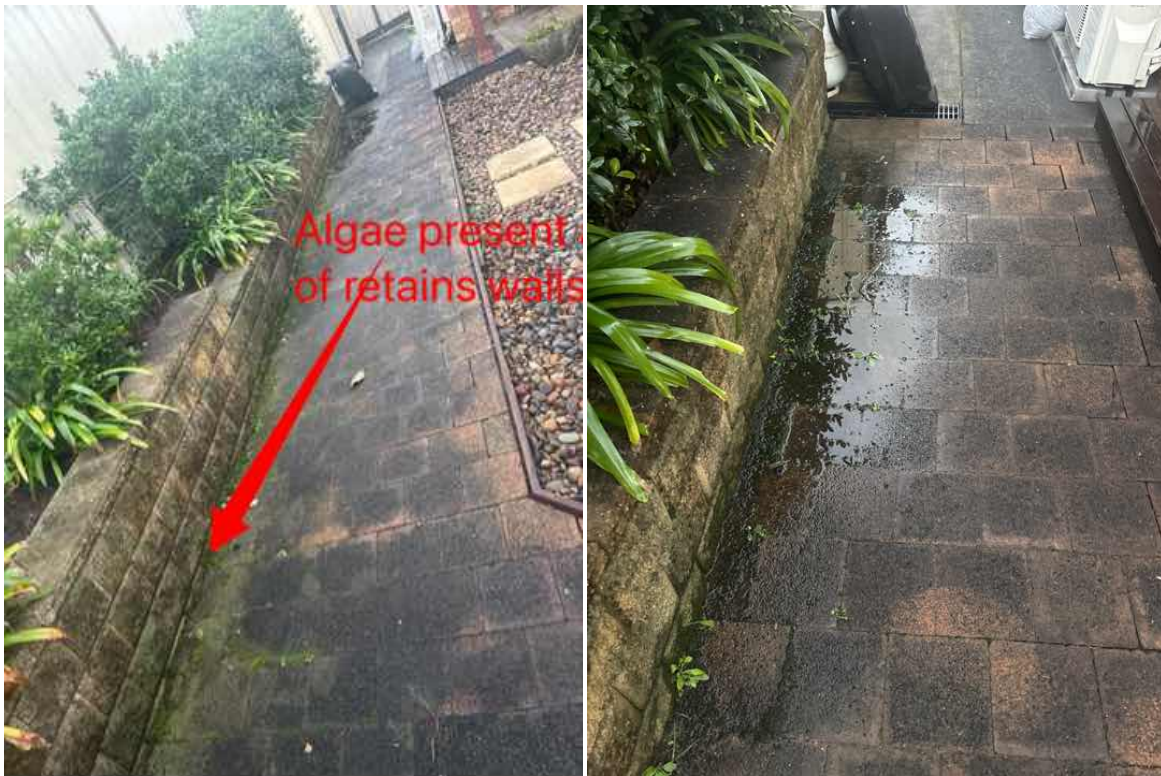
There is evidence of drainage issues. Consult with the vendor regarding any plumbing/drainage issues prior to a decision to purchase as this will require the service of a licenced plumber for further advice and recommendations.

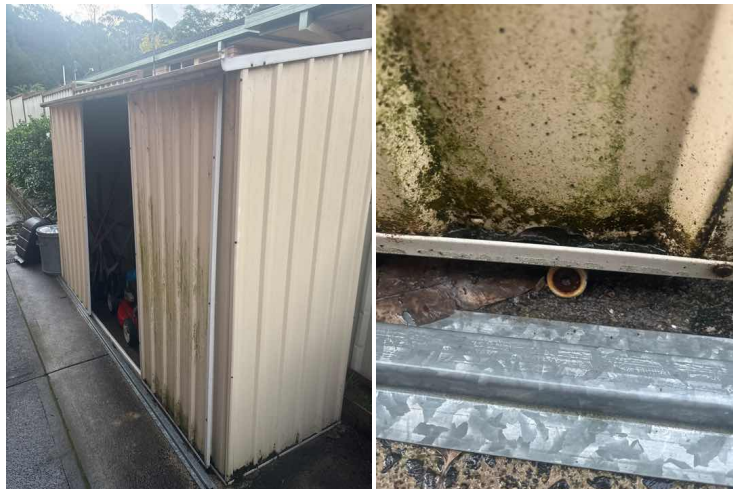
The door rollers requires replacement.

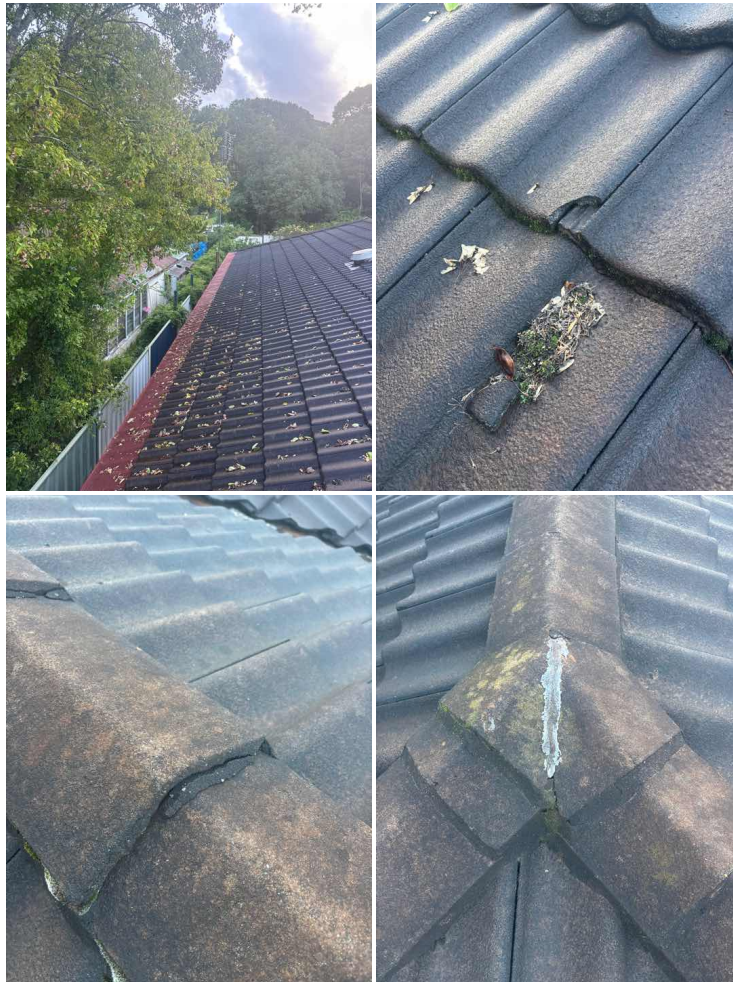
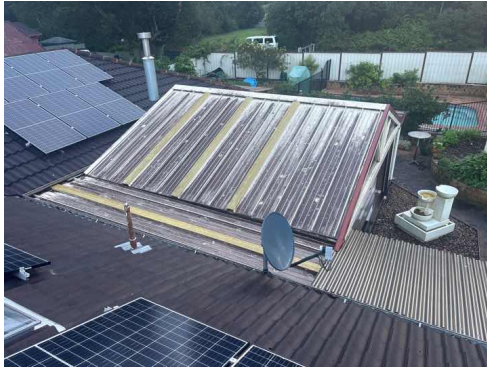
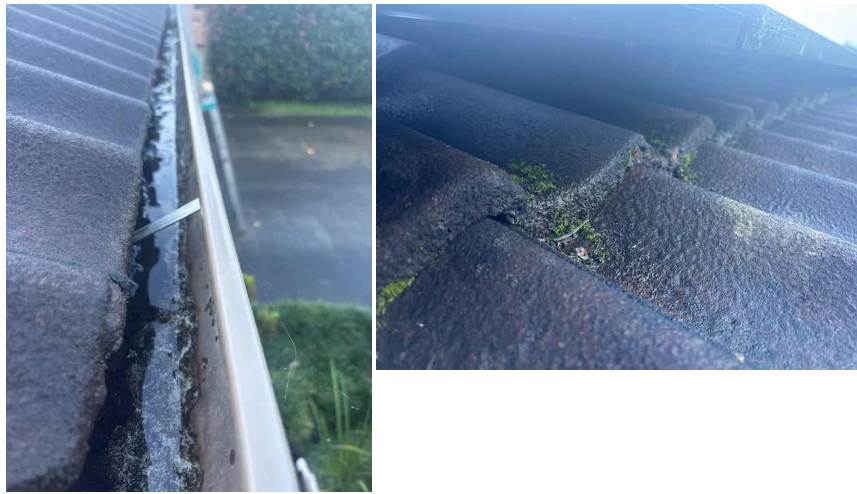
Cracked tiles visible. Contact a roof tiler for repairs. This has potential to become a serious issue if repairs aren't carried out due to water ingress into the roof cavity.

Mortar cracks visible. We recommend having these repaired by a qualified roofer as they may contribute to water ingress.

Moss has built up on the tiles over time. It is preferable to have removed / cleaned to prevent deterioration.

Trees overhang on roof - Recommendations: Cut back to prevent damage and blocked guttering and associated problems.

Recommendations: A qualified roof restoration contractor should be engaged for advice and recommendations.

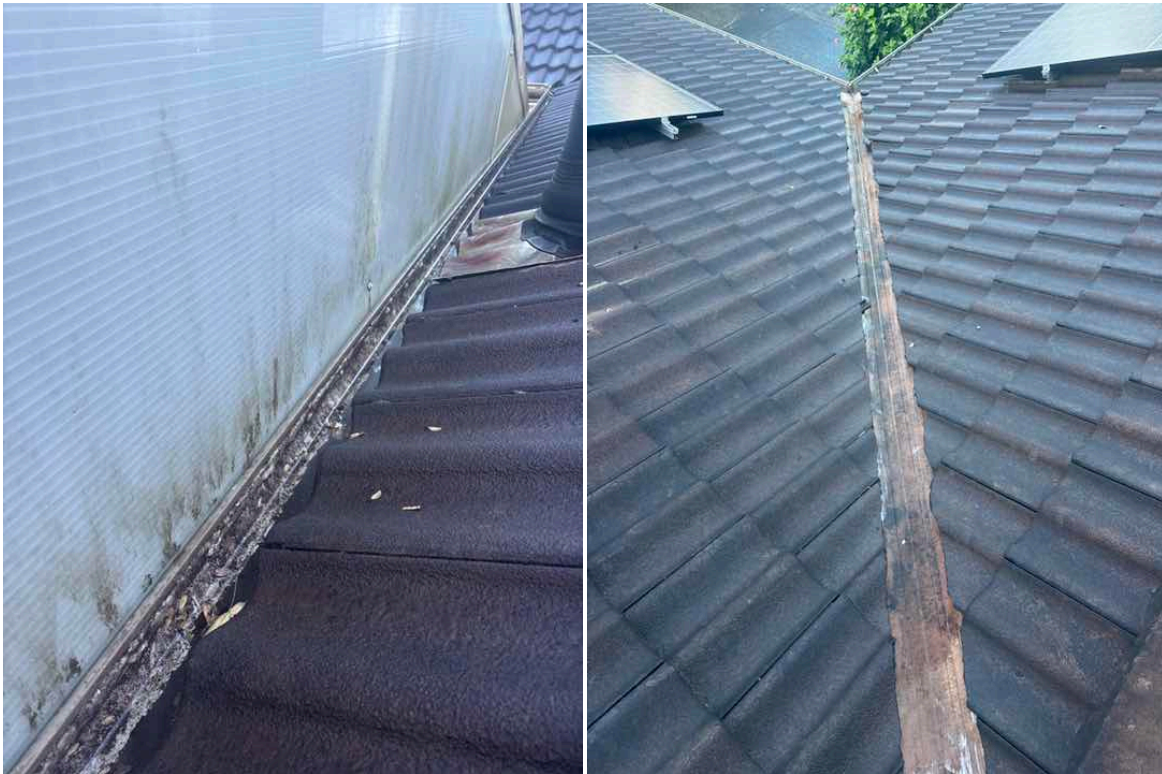
Minor flashing rust sections. A qualified roofer should be engaged for repairs and recommendations.

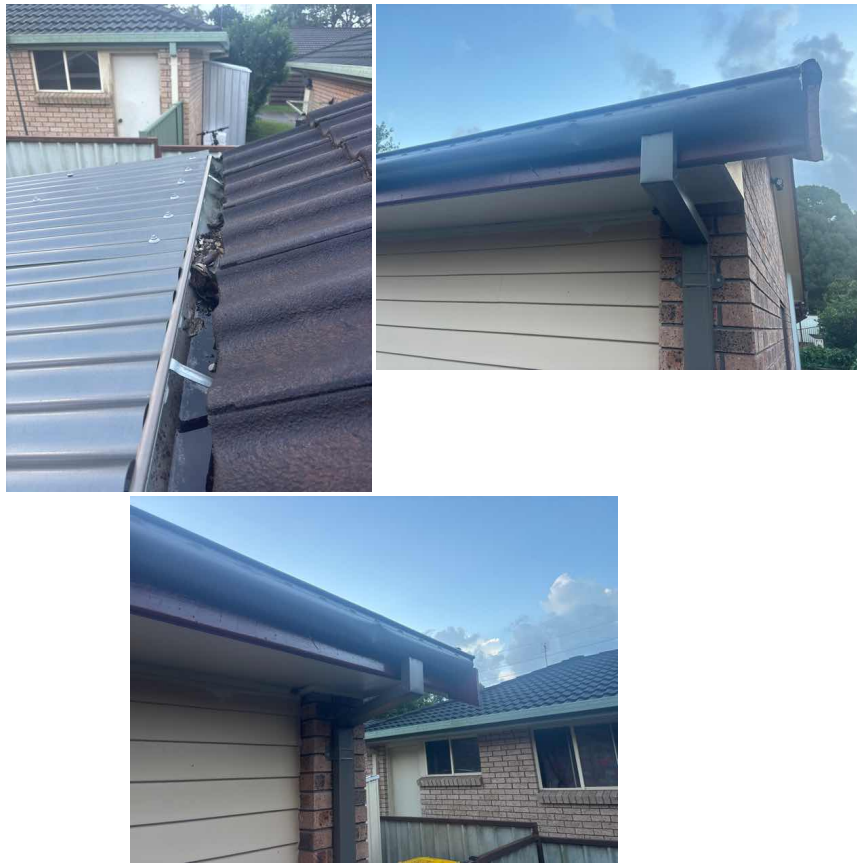
Debris in guttering areas- this requires cleaning out to prevent blocking of downpipes and leaking into eaves and fascia. Have gutters cleaned and assessed by a plumber for adequate fall. Regularly clean to prevent ponding. Ponding water will contribute to rust.

Impact/Denting damage observed. Replace as required.

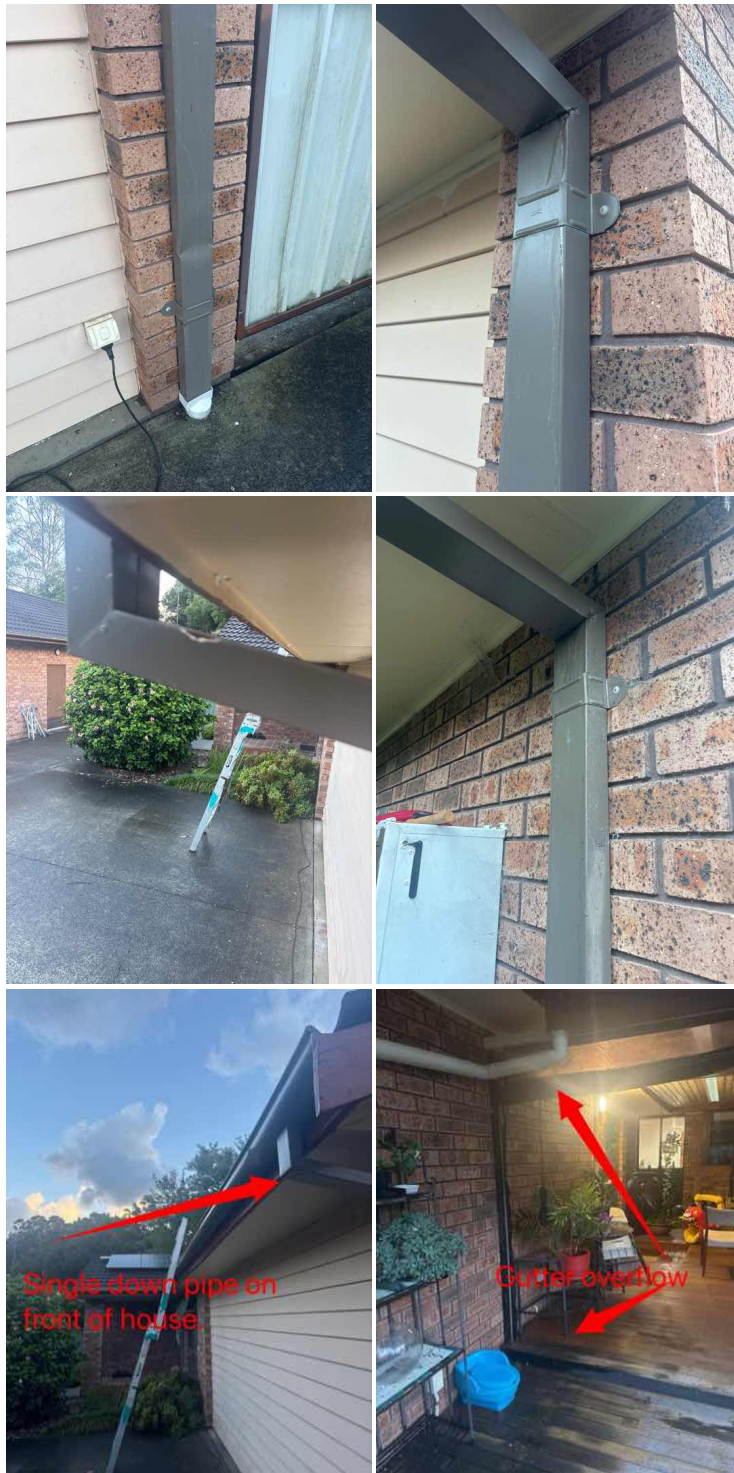
Impact damage noted to downpipe. Contact a roof plumber for replacement as required.

Insufficient in the inspectors opinion. Add more to aid with water evacuation. Contact a roof plumber for further advice and recommendations.

Front gutter was only one down pipe servicing roof. This is insufficient as evident in heavy rainfall. This may also be contributing to moisture in living room walls

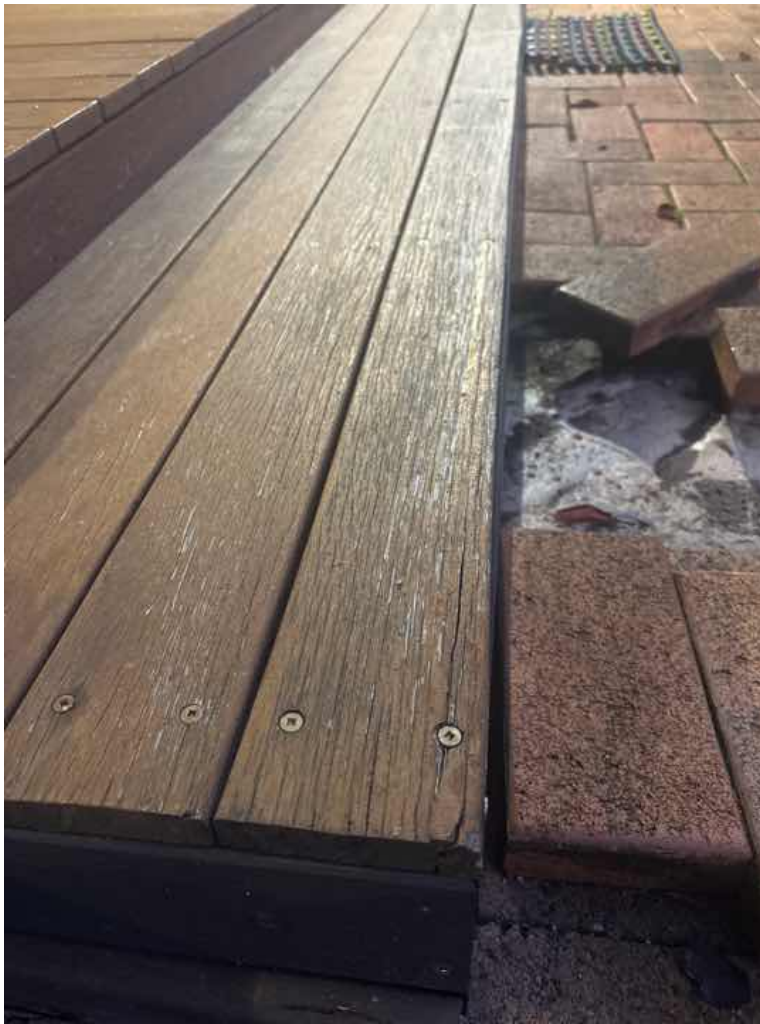
General timber decay in decking components. A qualified carpenter should be engaged for advice and recommendations.

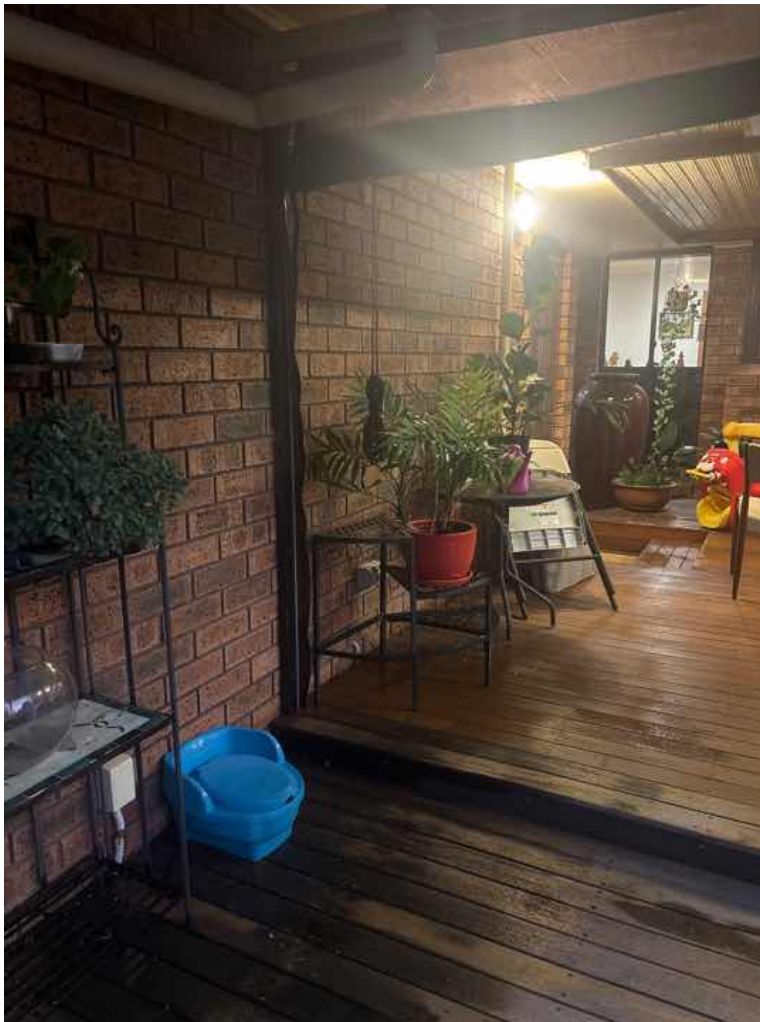
High levels of moisture detected. At this point the source of the leak appears to be the guttering system. We recommend monitoring this during rain fall. Contact a qualified roof plumber for repairs.

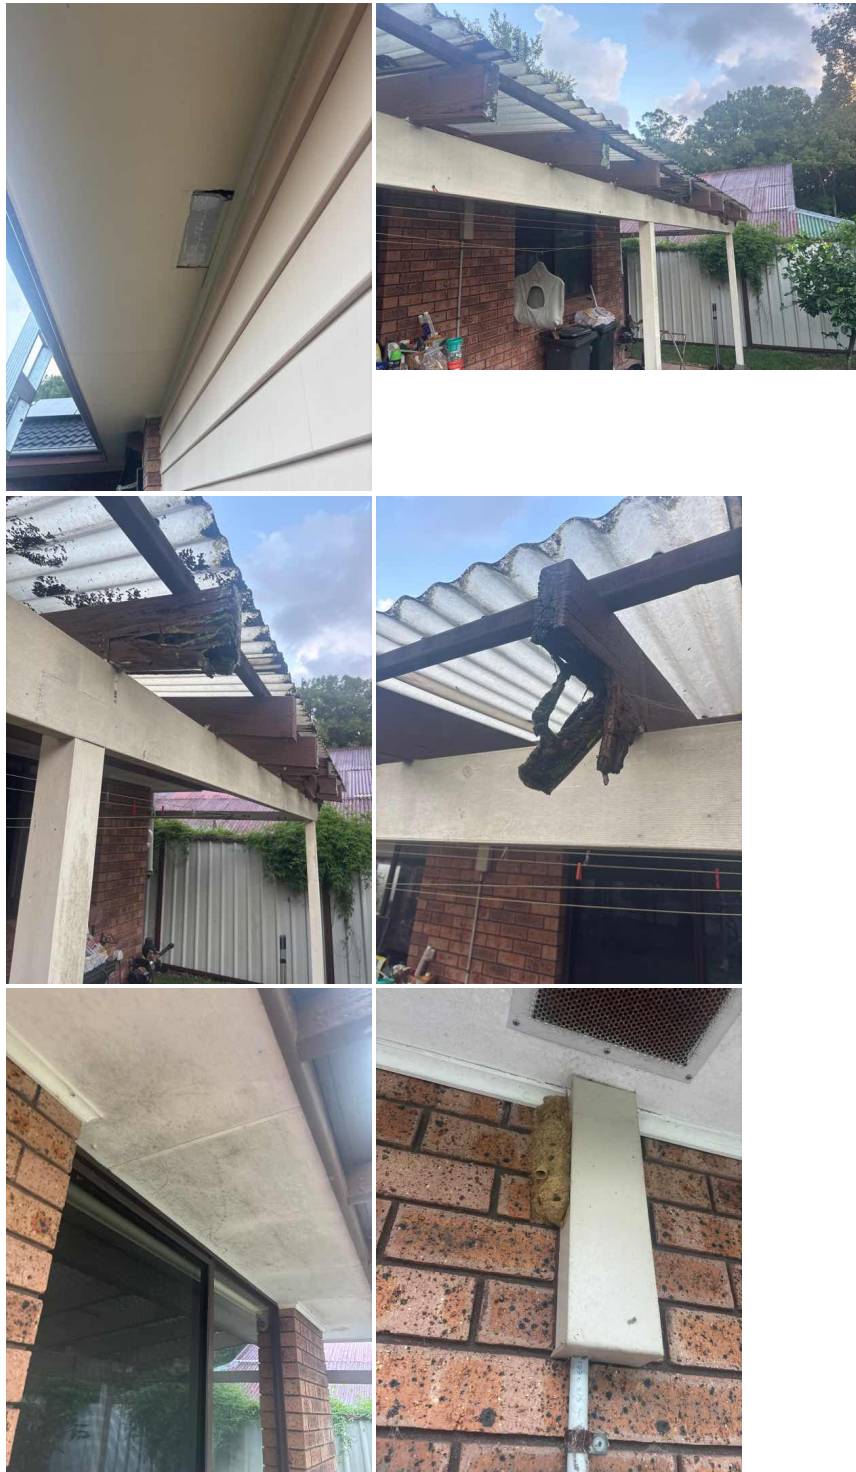
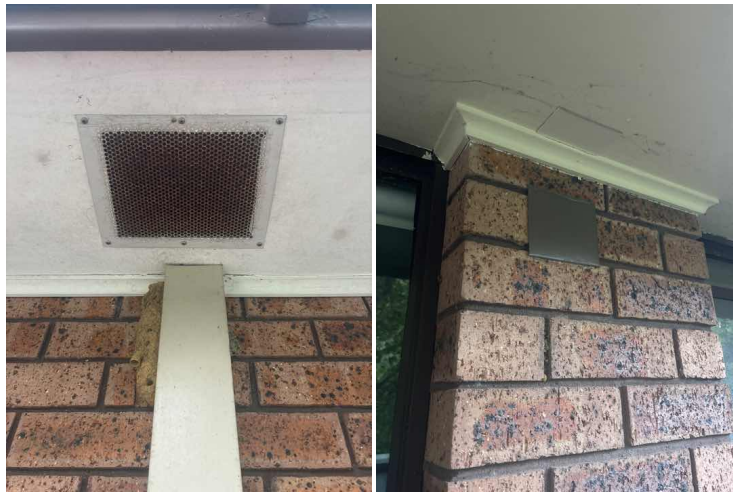
Minor eave deterioration & ageing evident. Recommendations: Maintenance works, general upkeep should be carried out.

Eave lining damage visible. Recommendations: A qualified carpenter should be engaged for repairs.

Eave lining timber fungal decay visible. Recommendations: A qualified carpenter should be engaged for repairs and recommendations.

Exposed common rafter ends are rotted/decayed. Recommendations: A qualified carpenter should be engaged to replace all affected rafters.

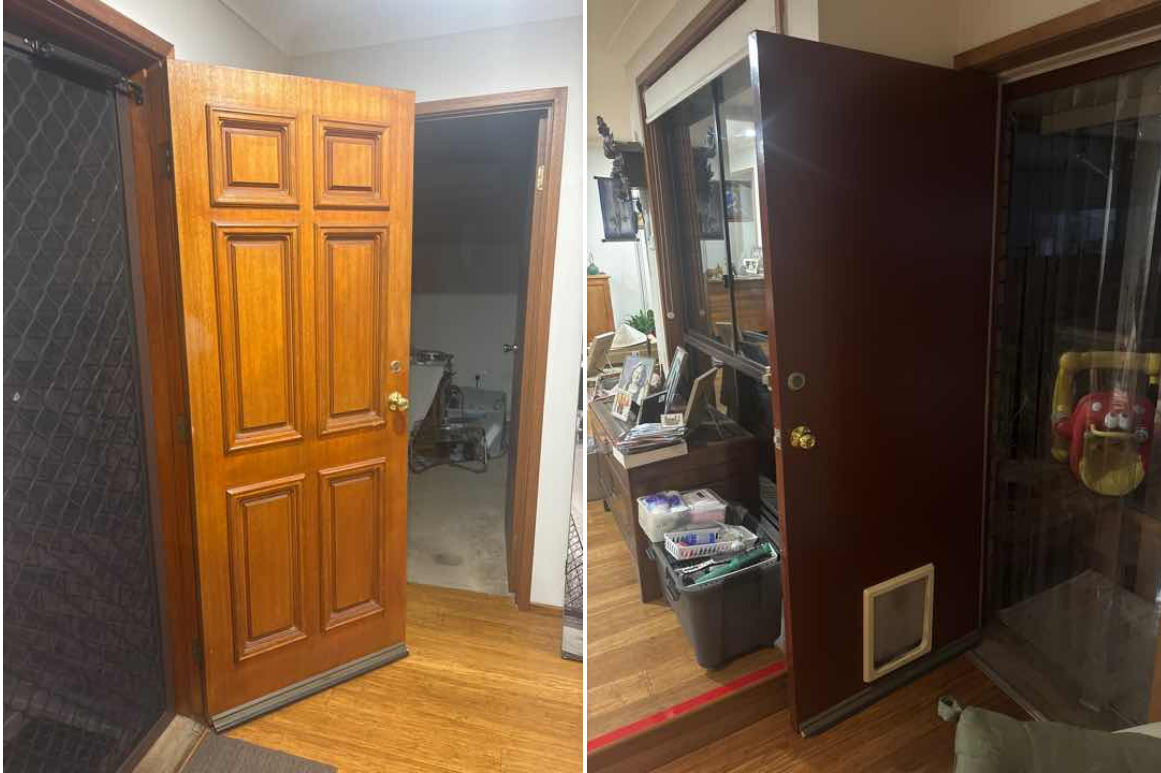
General age/damage has occurred to door frame, face or components. Recommendations: A qualified carpenter should be engaged for advice and recommendations.

Hardware is binding against closing jamb. A qualified carpenter should be engaged to fix issue before further damage of the dead lock occurs.

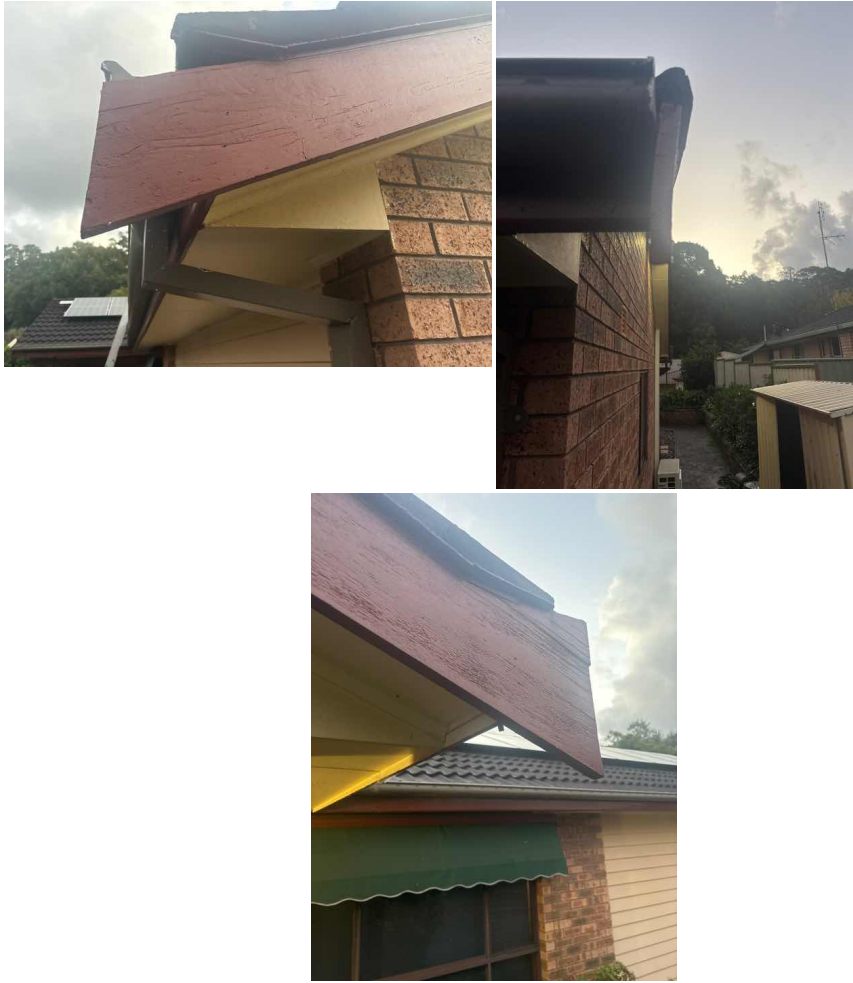
Minor deterioration & ageing evident. Recommendations: Maintenance works, general upkeep should be carried out.

Impact/Denting damage observed.

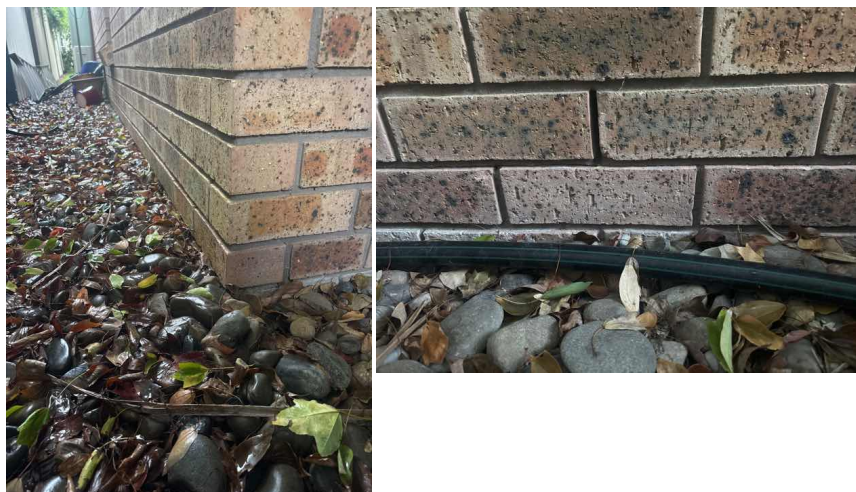
Area where first brick course sits on concrete step down has been covered by pebbles, alfresco decking and/or concrete. Failure to have concrete slab exposed increases potential termite ingress and continual exposure to rising damp.

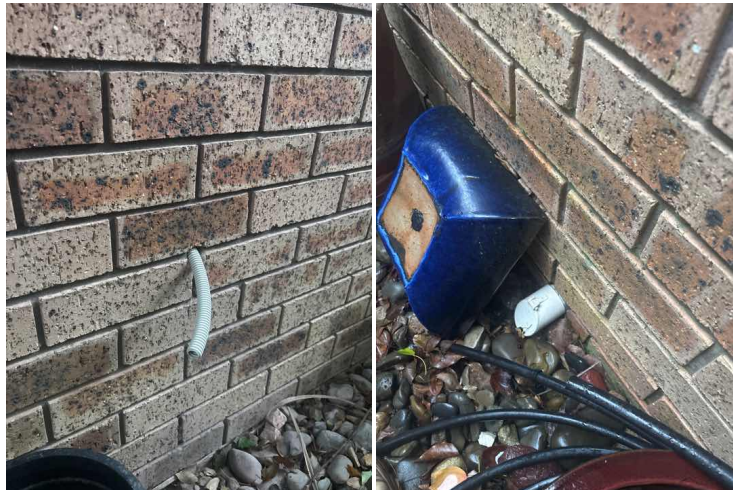
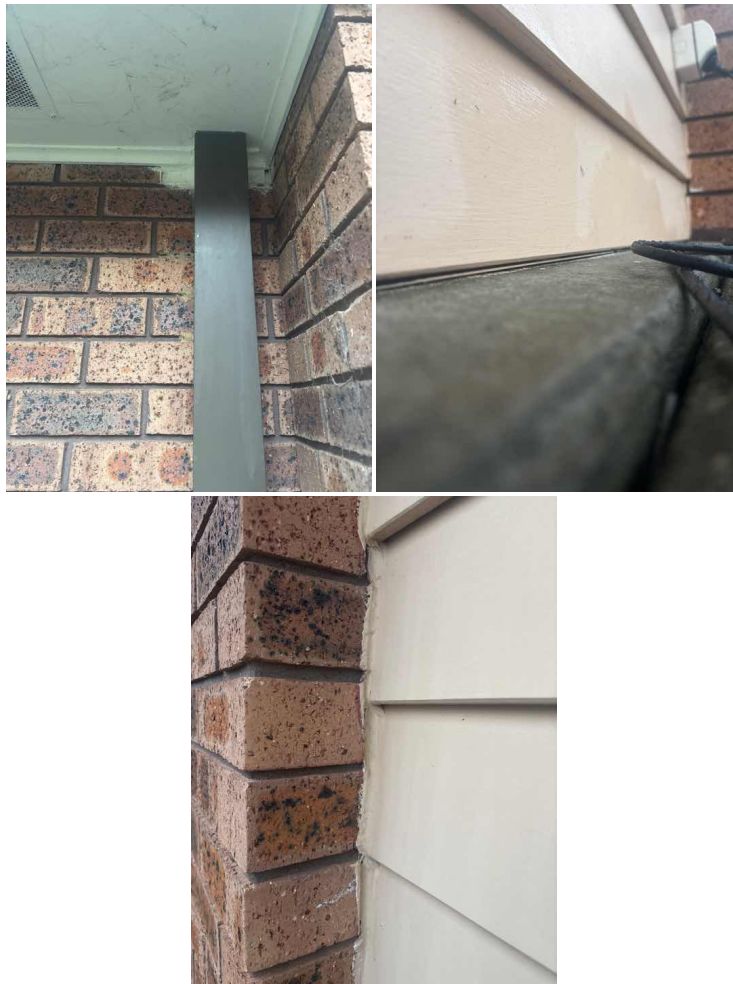
External cladding is in contact with the ground. This is a conducive condition for moisture penetration causing decay and/or concealed termite entry. Contact a licensed builder for recommendations.

Poor installation of cladding work noted. Incorrect installation methods have been noted for specific board type.

Rising damp detected. A qualified damp proof specialist should be engaged for advice and recommendations. Accurate diagnosis of the cause and extent of the damp problem is very important. It is strongly advised that you have this issue assessed prior to purchasing the dwelling as can be quite costly if a damp proof course has to be reinstated.

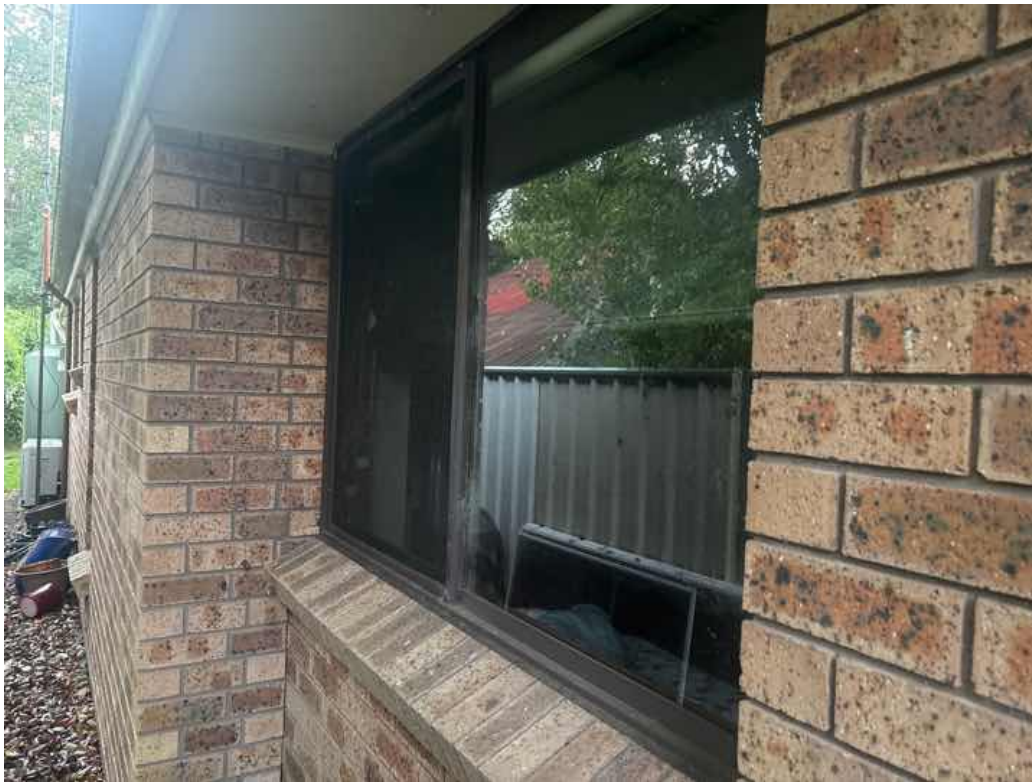
General age/damage has occurred to window components. Recommendations: Restoration work recommended. A qualified carpenter should be engaged for advice and recommendations.

Fly screens show signs of age. Near future replacement is recommended

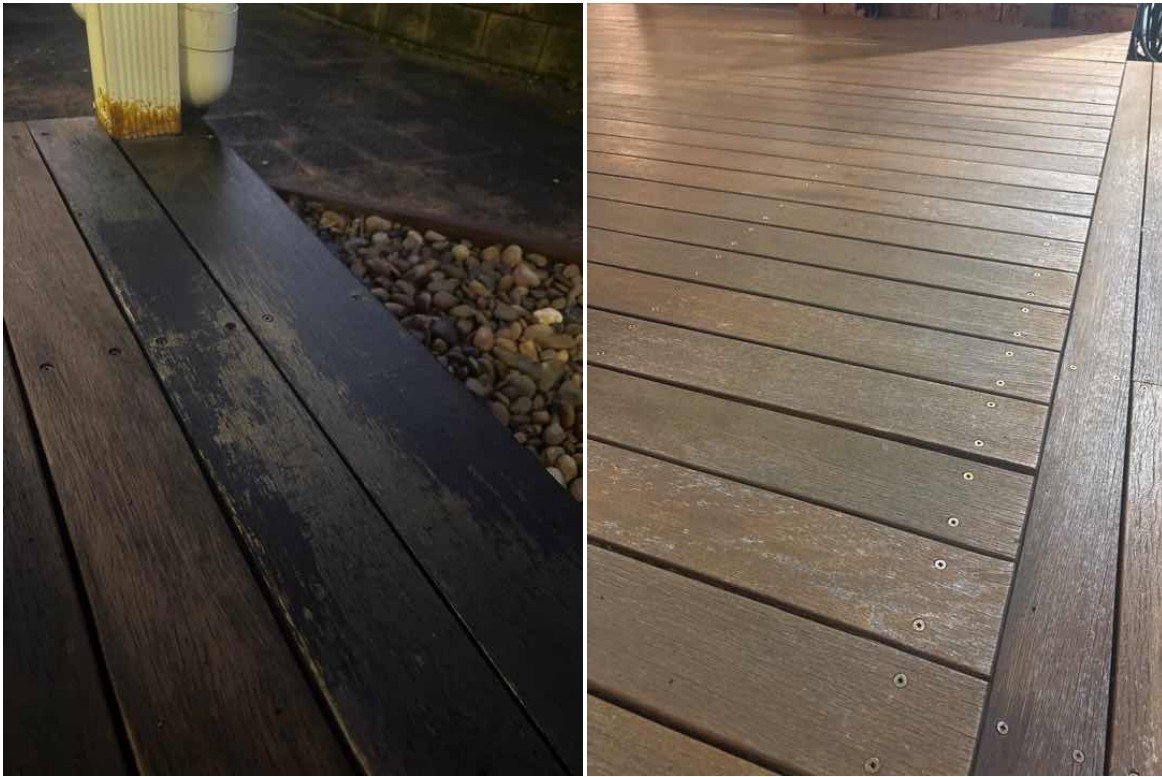
Deck too low to the ground and edge boards restrict any access for framework condition

Decking board surfaces are weathered. We recommend cleaning and maintenance as needed.

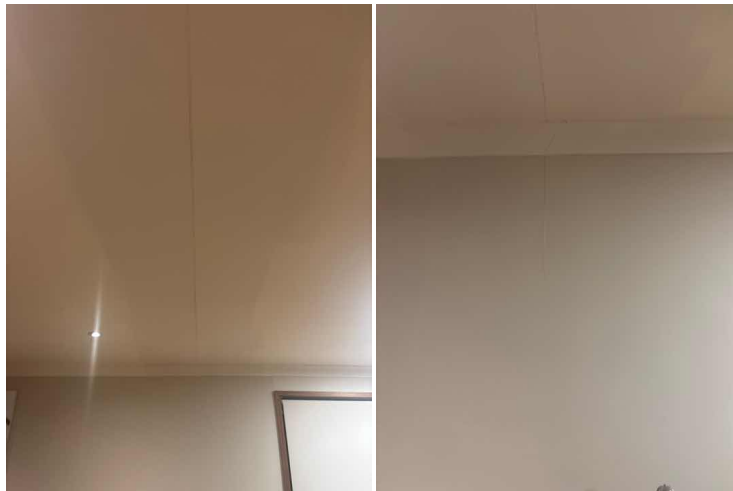
General ageing and/or denting and the like is evident on ceiling linings - Recommendations: A qualified painter should be engaged to assess and repair as required.

Ceiling join crack patching is evident. I recommend you contact a qualified painter for further advice and recommendations.

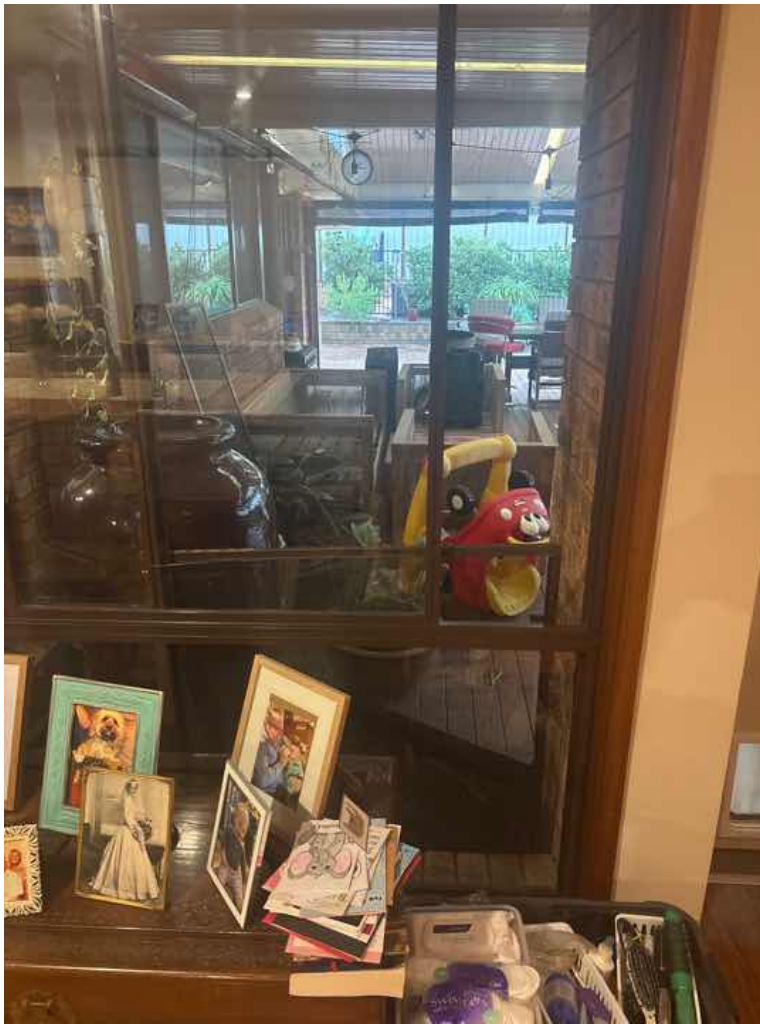
General age wear deterioration - The window frame/components showed evidence of ageing and wear. General maintenance works required.

Fly screen laying in ground in front of window

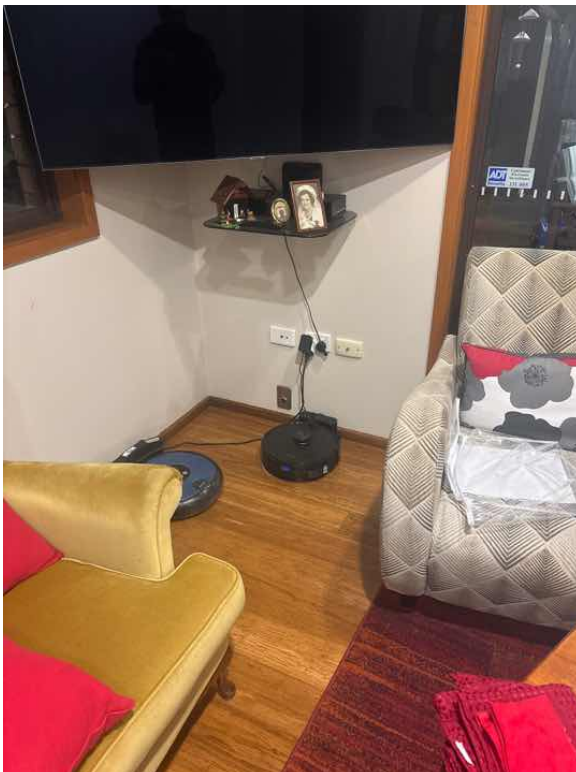
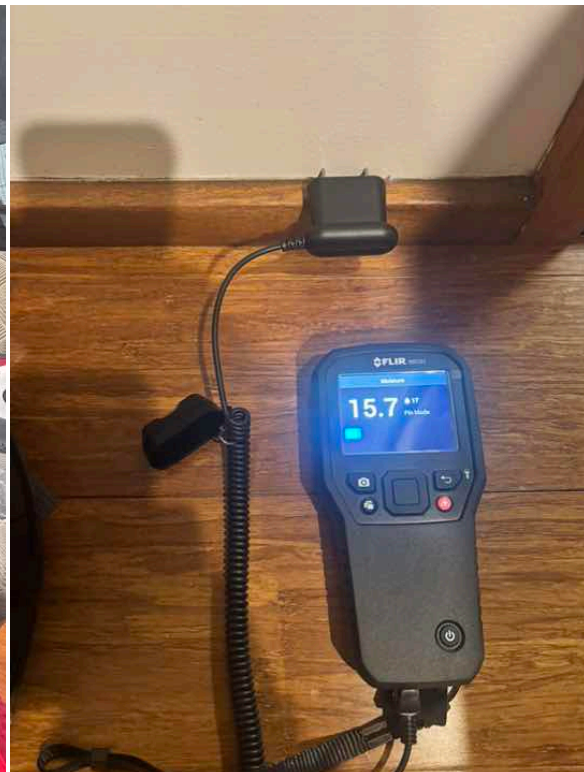
High moisture levels detected indicating rising damp. there can be other causes such as water ponding against the wall or poor drainage in that particular area. Rising damp in one area of the dwelling may mean that other sections of the dwelling may be affected and not yet visible. Contact a specialist in this field for repairs and advice. We recommend getting a quote prior to a decision to purchase as this can be very expensive to rectify.

Using an invasive moisture reading, results showed that the dry wall had over 15% of moisture. This indicates that there is a high level of moisture in the wall

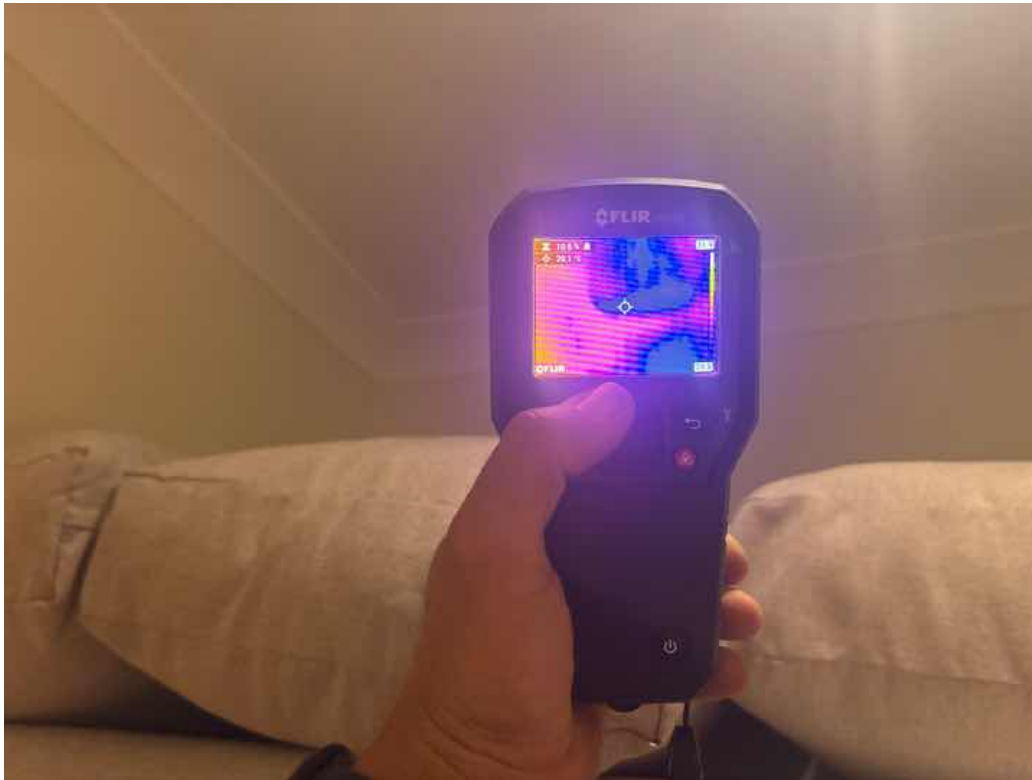
Thermal imaging noticed a potential damp spot in the ceiling corner above refrigerator. Fridge was in the way in order to obtain an accurate moisture content reading. Further investigation in the area is highly recommended.

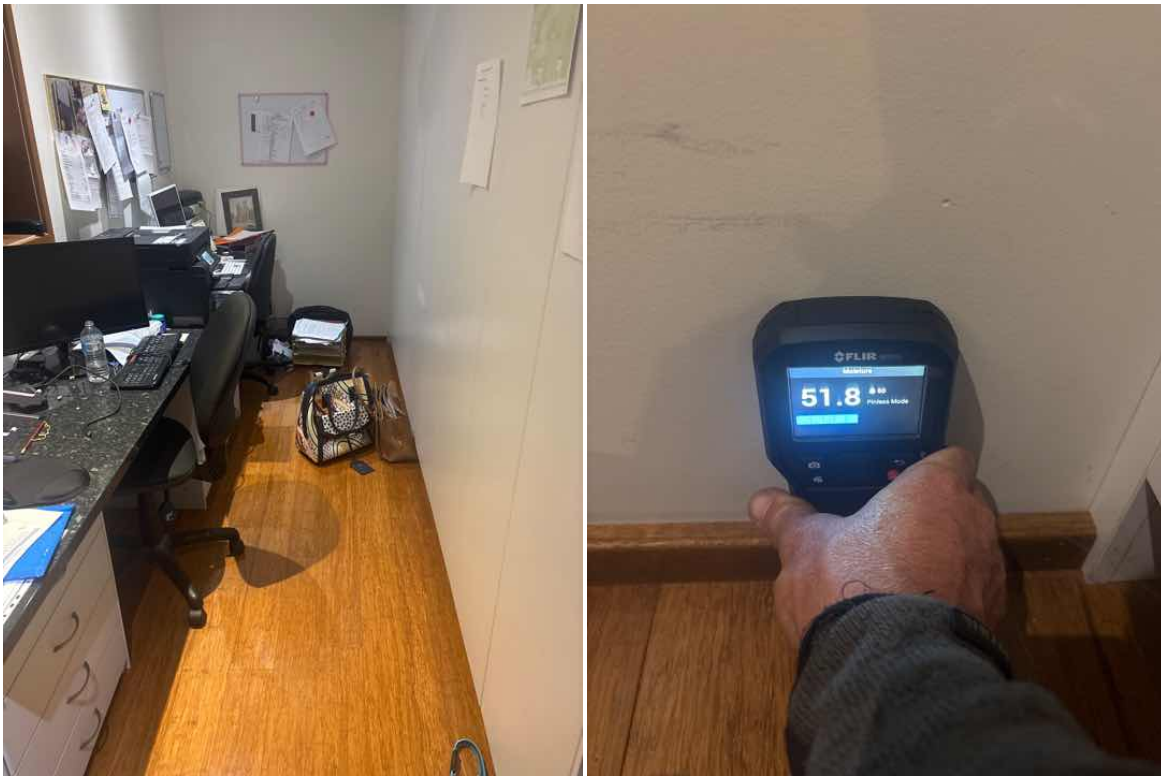
High moisture levels detected indicating rising damp. there can be other causes such as water ponding against the wall or poor drainage in that particular area. Rising damp in one area of the dwelling may mean that other sections of the dwelling may be affected and not yet visible. Contact a specialist in this field for repairs and advice. We recommend getting a quote prior to a decision to purchase as this can be very expensive to rectify.

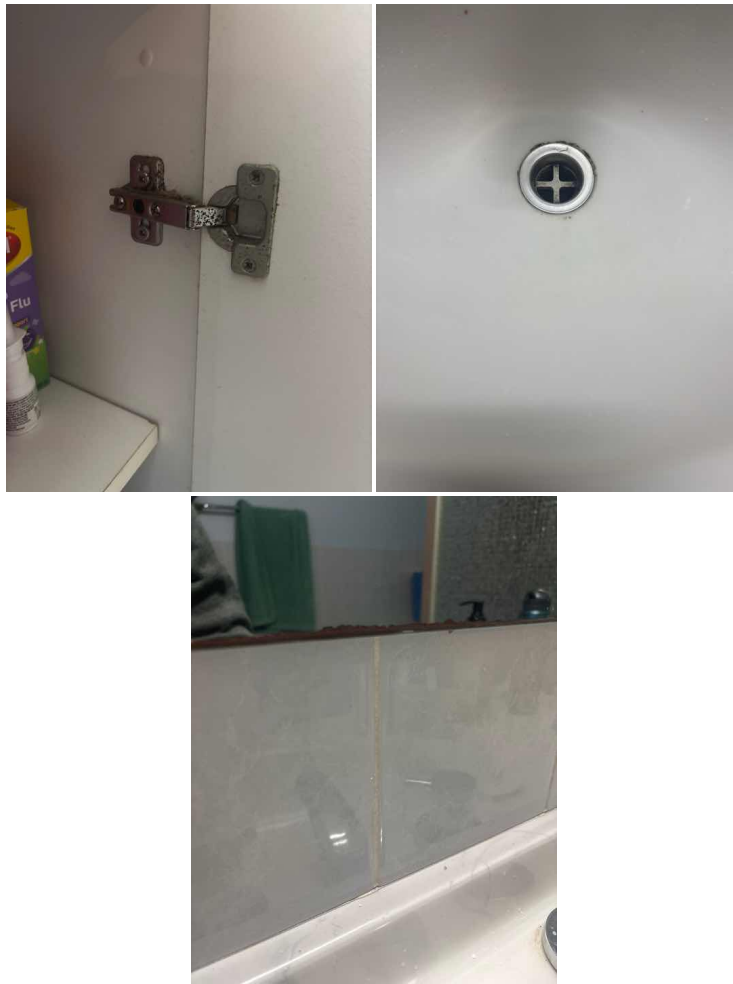
The vanity mirror is desilvering at edges. Replacement recommended.
