# Inspection Report

**PRO BUILD Inspections**

**The Scope of the Inspection:** This report Complies with Australian Standards AS 4349.1-2007. Inspection of Buildings Part 1: Pre- Purchase Inspections-Residential Buildings- Appendix "C"

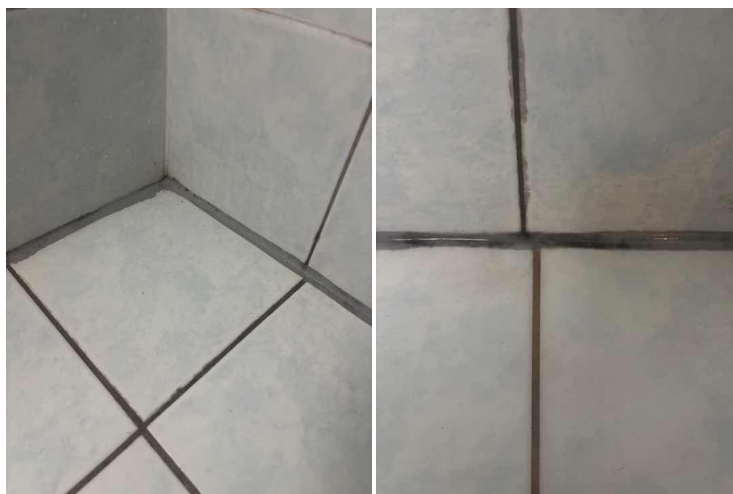
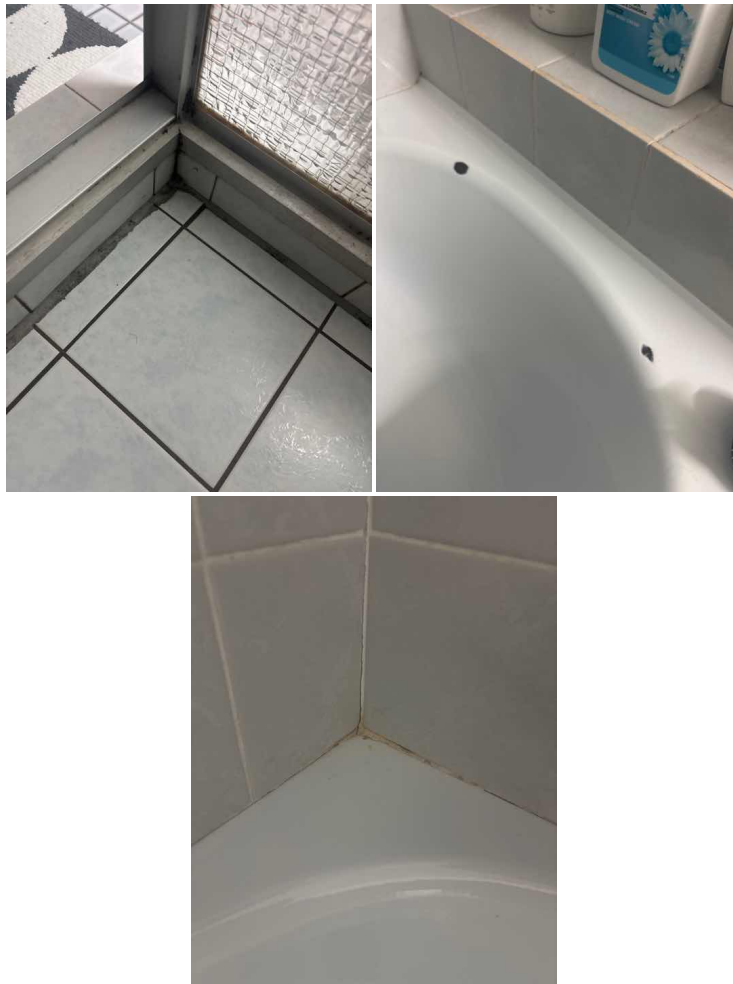
The bath tub is deteriorate. Refinish or replace. Contact a qualified plumber for recommendations and repairs

Silicone sealant has been applied to the interface of the floor and walls in the shower recess in an apparent attempt to prevent water penetration to surrounding areas. This method of repair can only be considered to be temporary. Further waterproofing may be necessary.

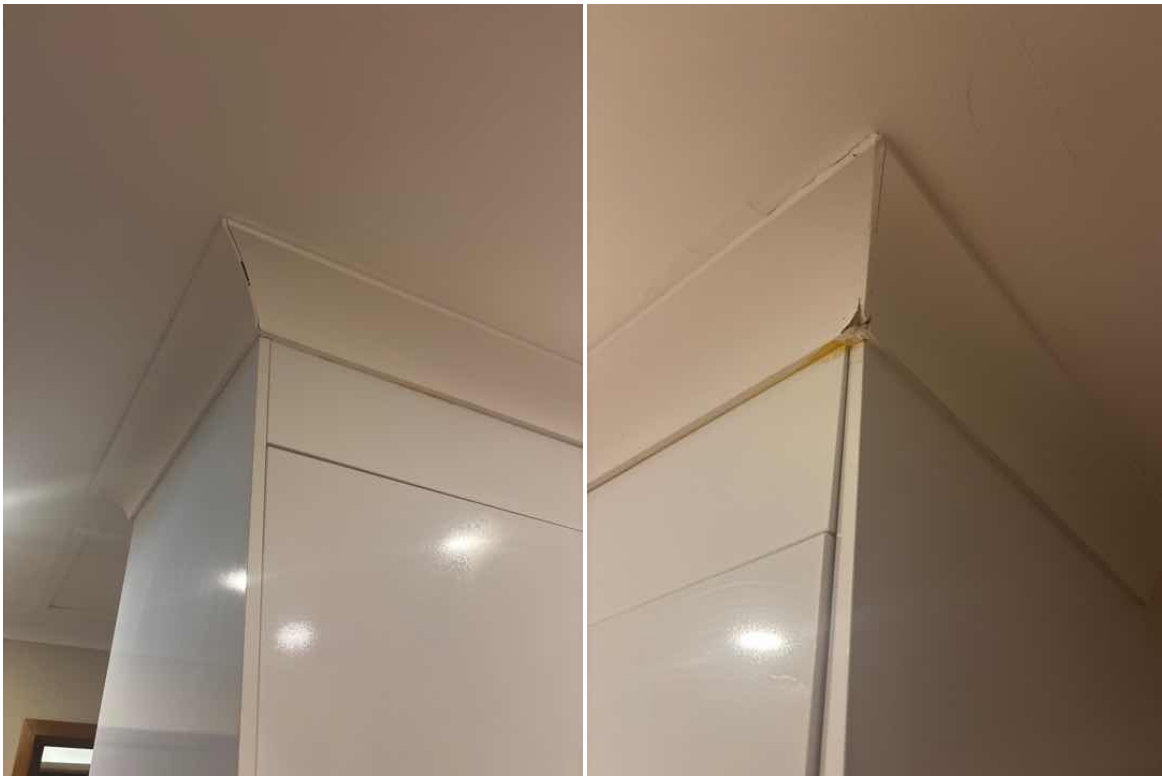
Minor cornice cracks - Minor cornice cracks visible. Recommendations: I recommend you contact a licensed plasterer for further advice and recommendations.

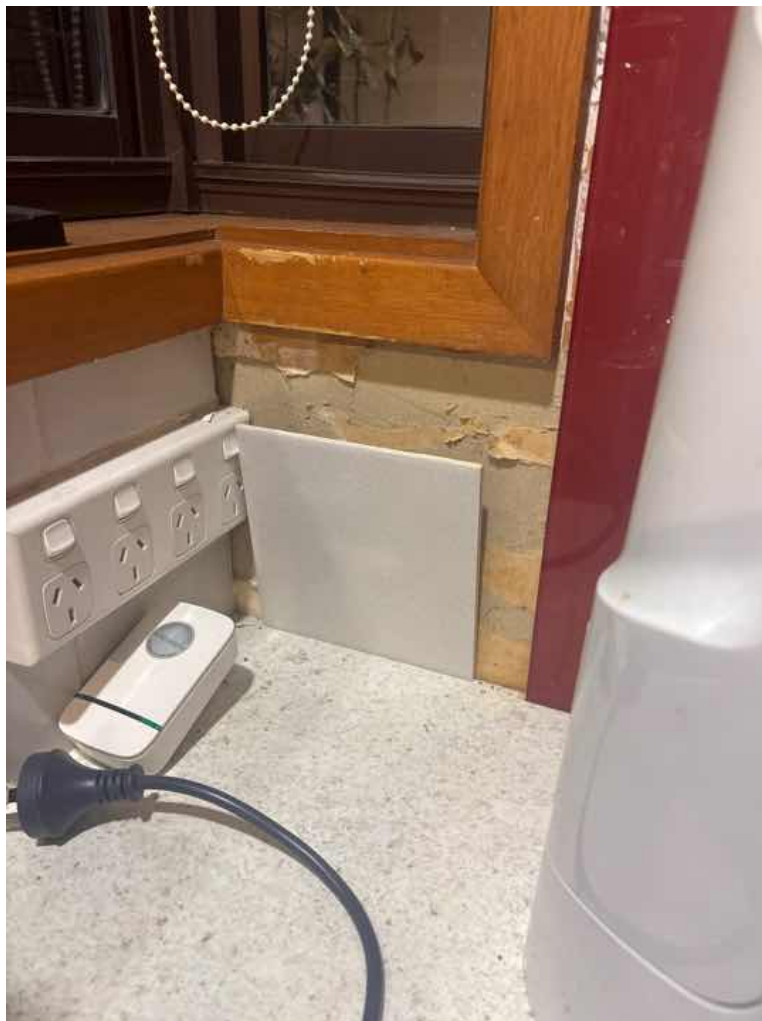
Damaged tile/s observed. Have repaired by a licensed tiler.

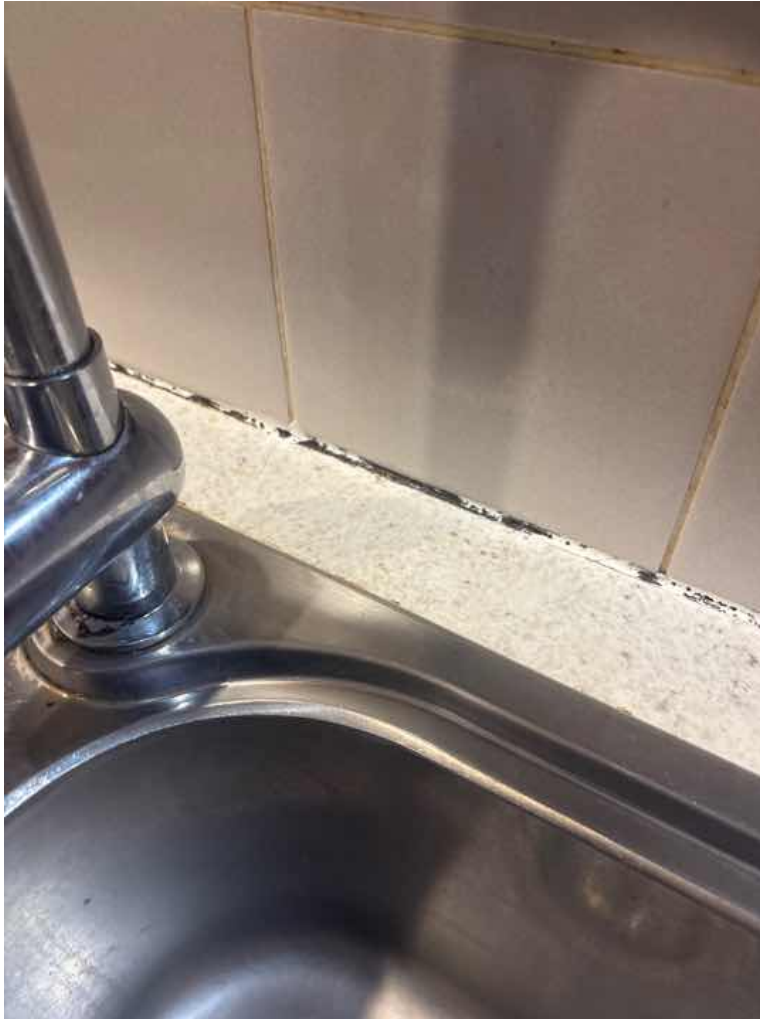
Mould was noted on the silicone sealant directly behind the sink tap. Sealant should be replaced in order to minimise water penetration behind tile and onto dry wall material.

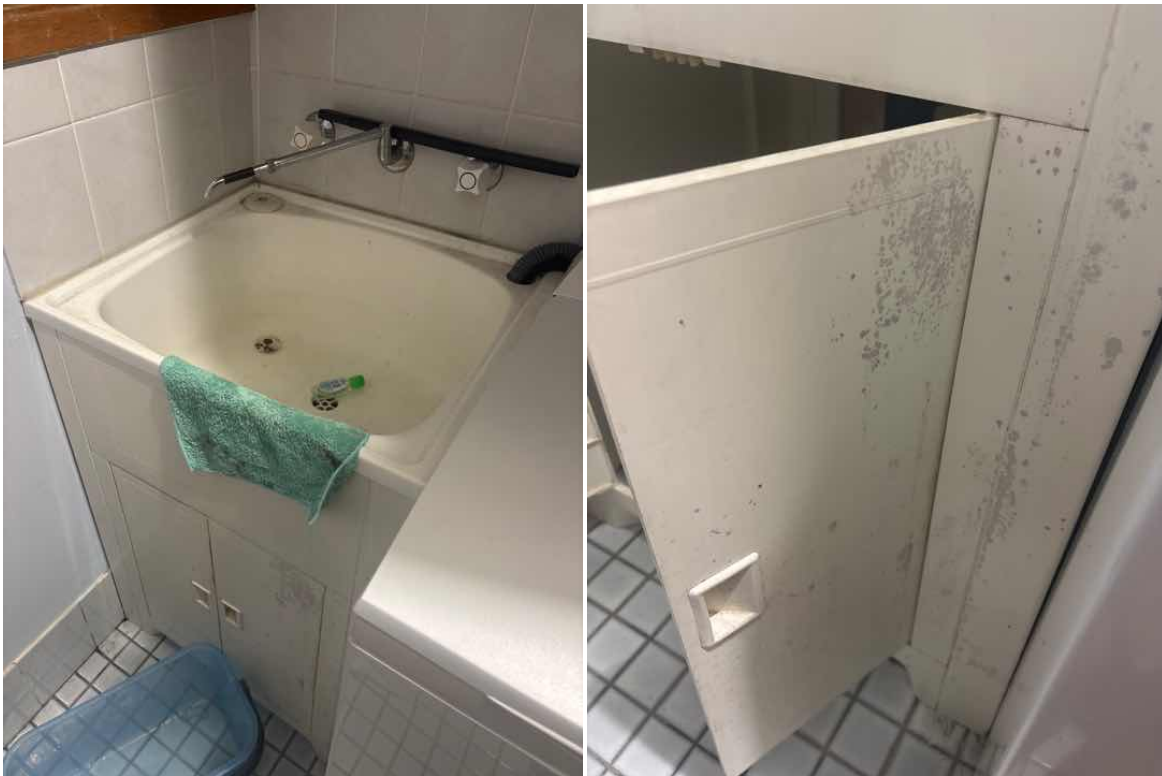
Tub is corroded. Replacement recommended.

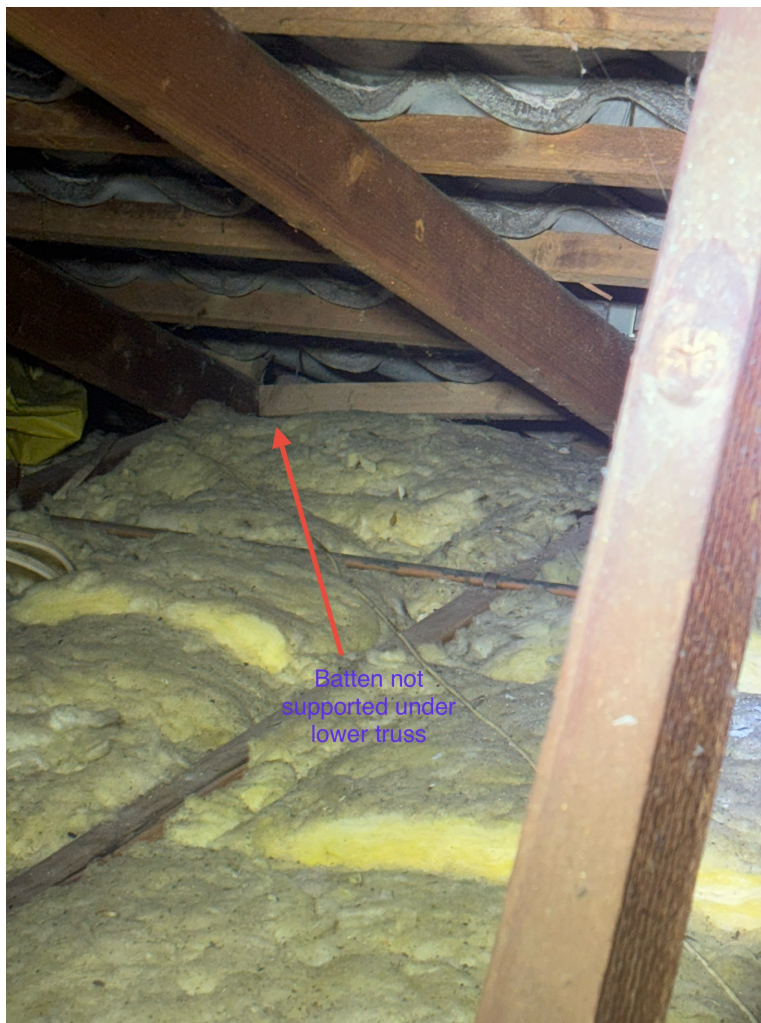
Deteriorated batons observed. A qualified carpenter should be engaged for advice and recommendations.
