# Inspection Report

**PRO BUILD Inspections**

**The Scope of the Inspection:** This report Complies with Australian Standards AS 4349.1-2007. Inspection of Buildings Part 1: Pre- Purchase Inspections-Residential Buildings- Appendix "C"

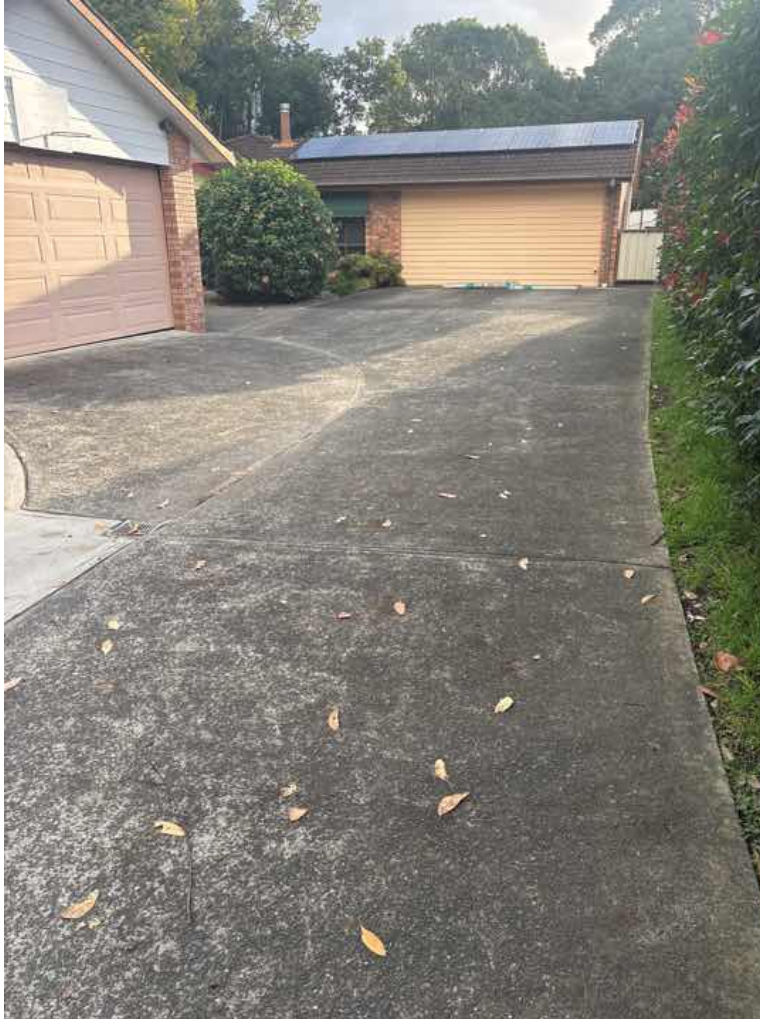
On visual inspection, the general condition of the driveway is serviceable.

Common cracks were observed on the driveway. Whilst these cracks appeared to be typical at the time of inspection, we strongly recommend you monitor these cracks and if worsening occurs contact a concreter for further advice.

Surface raised and settled in some areas. This can cause water ponding. Relaying recommended.

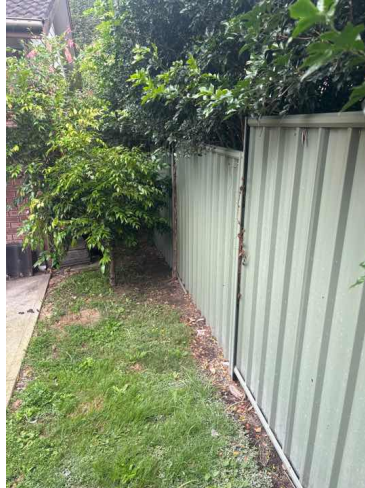
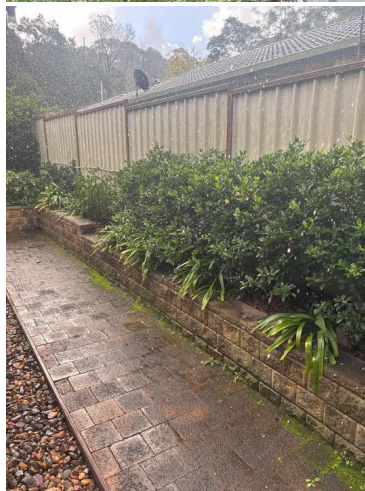
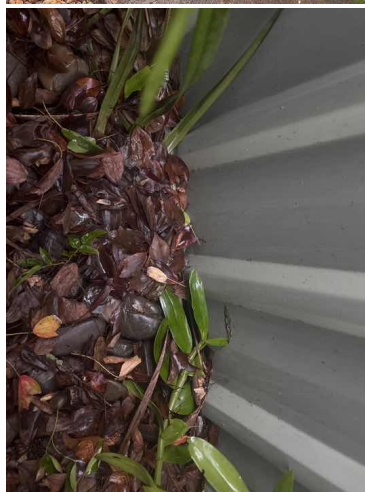
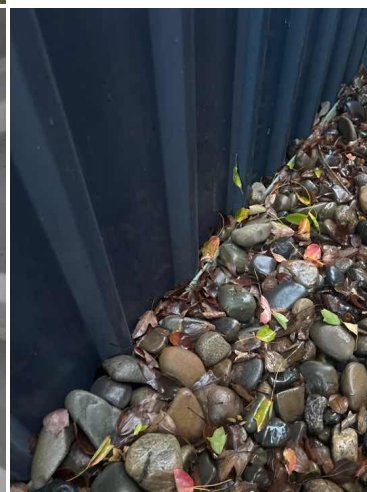
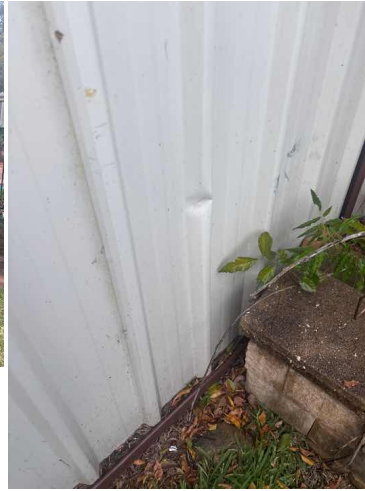
General age to fence components. General upkeep and maintenance required. A qualified fencing contractor should be engaged for repairs.

Impact damage noted to some fence panels.

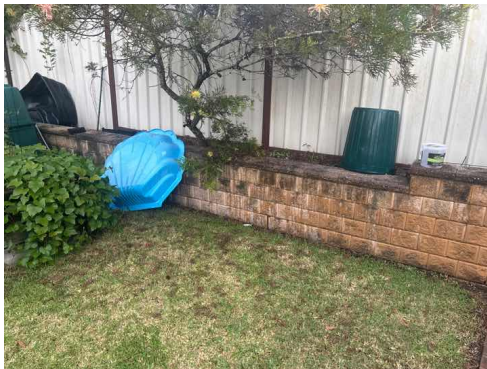
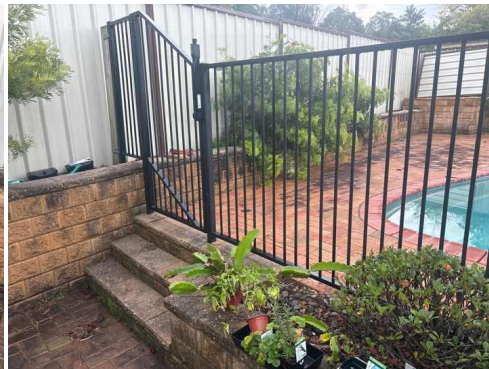
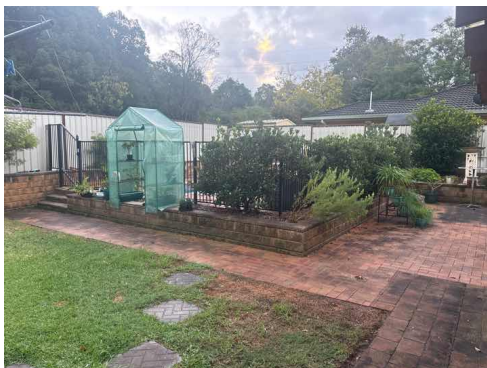
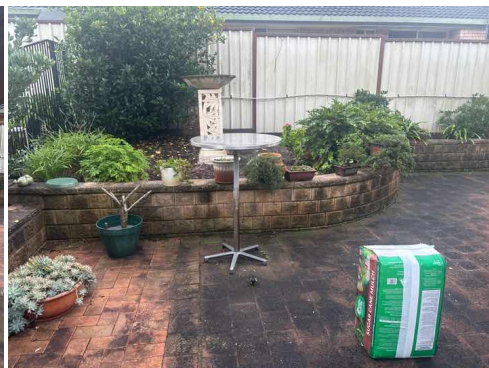
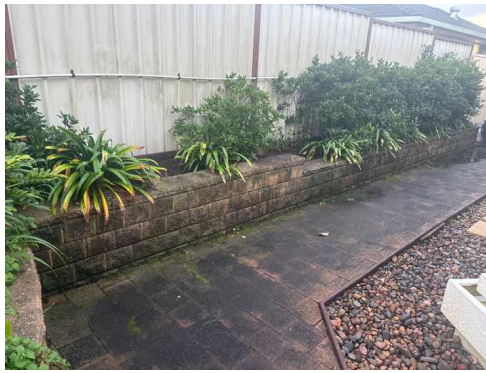
Of the visible areas, the general condition is serviceable or in reasonable condition for age of dwelling.

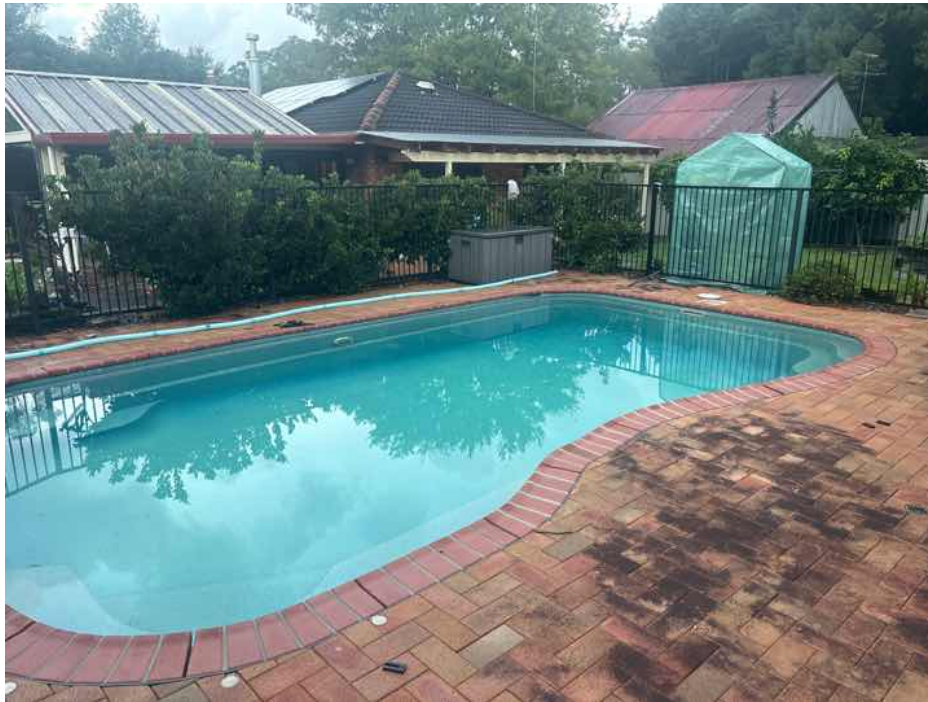
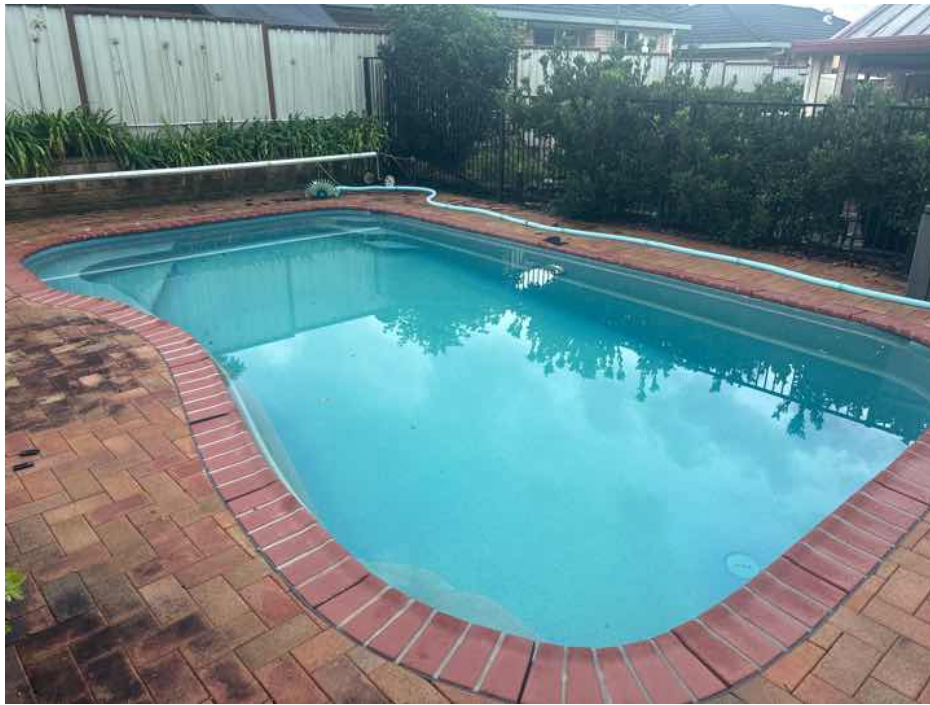
The appropriate warning signs do not appear to be present. You should check with your local council regarding the required signs.

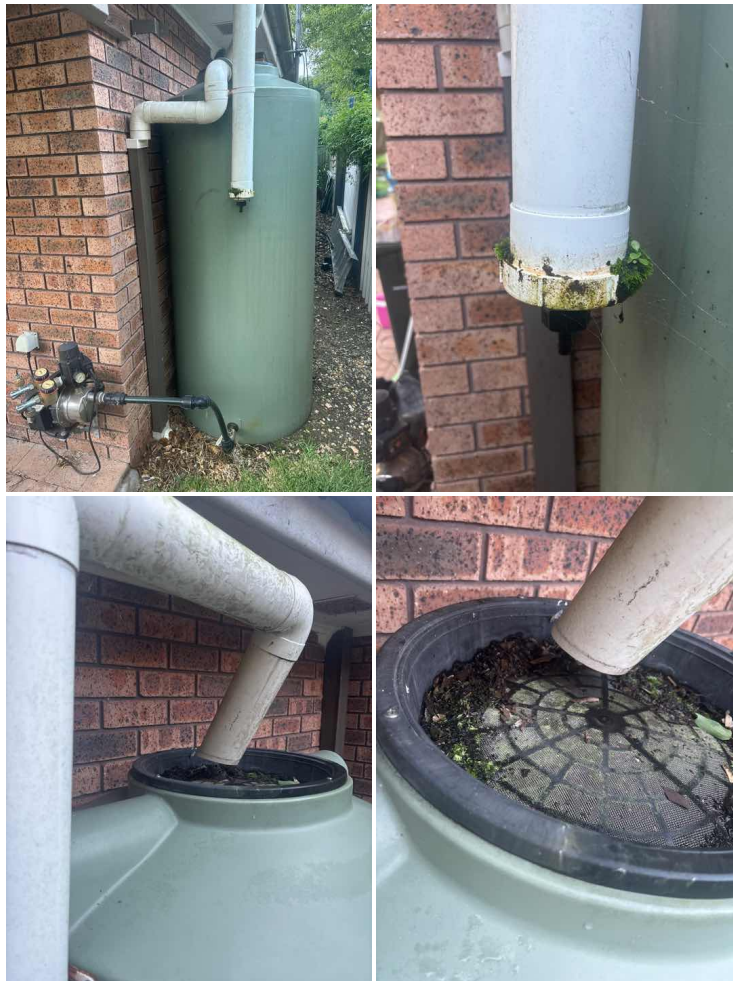
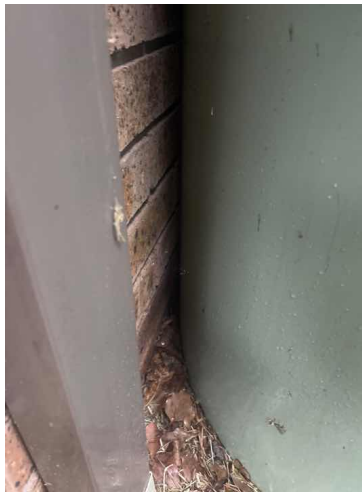
On Visual Inspection the water tank appears serviceable, but should be checked by a qualified plumber.

Water tank is hard up against brick wall. This does not allow proper ventilation nor visual inspection for damp proof course or termite tracing

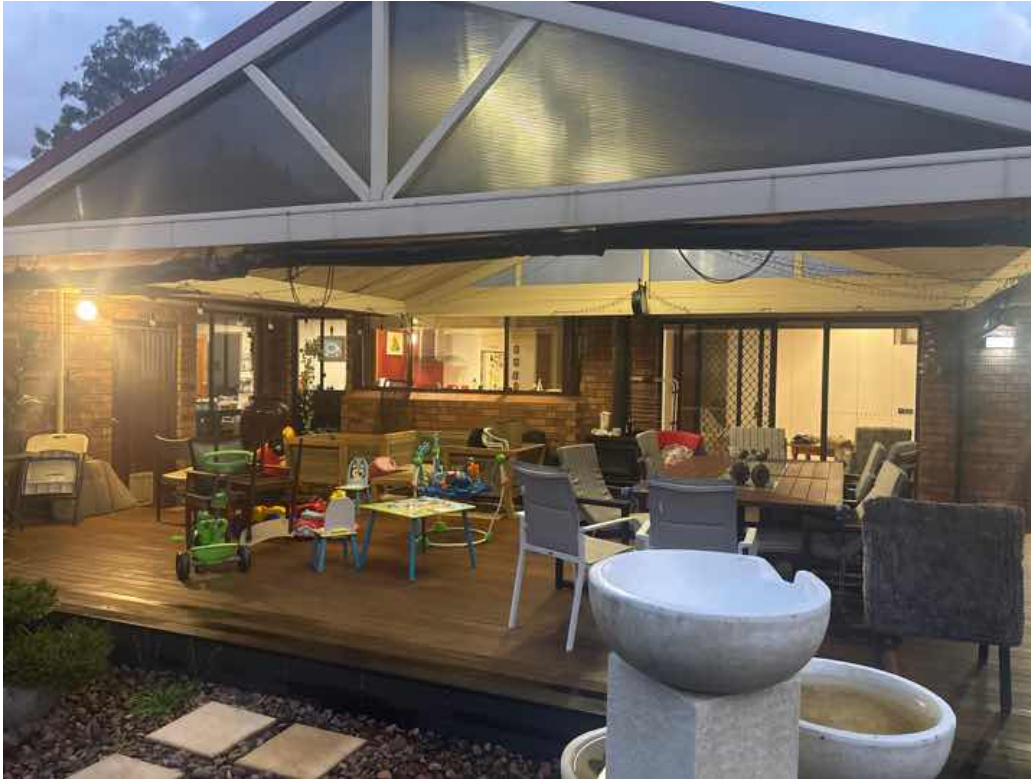
General timber decay in decking components. A qualified carpenter should be engaged for advice and recommendations.

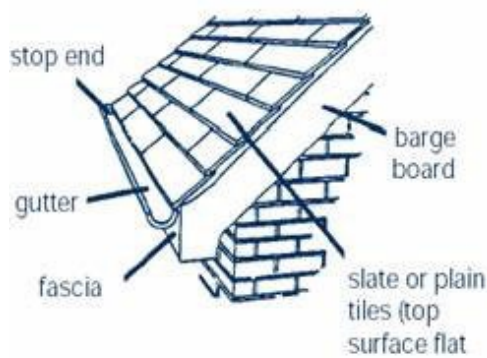
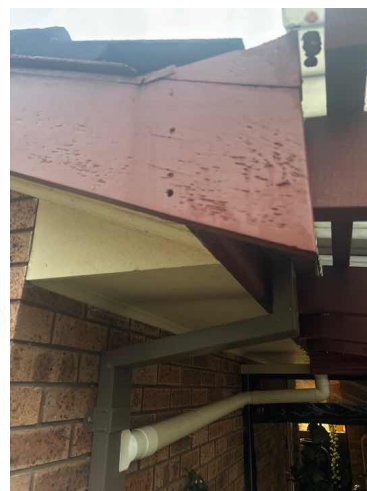
Minor deterioration & ageing evident. Recommendations: Maintenance works, general upkeep should be carried out.

Impact/Denting damage observed.

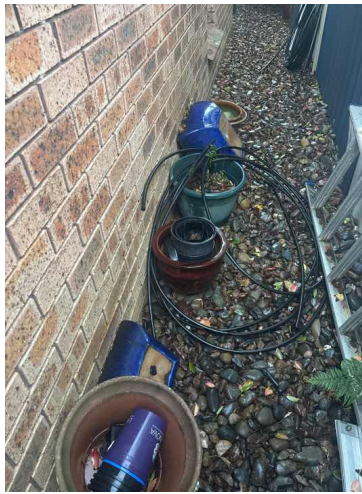
Area where first brick course sits on concrete step down has been covered by pebbles, alfresco decking and/or concrete. Failure to have concrete slab exposed increases potential termite ingress and continual exposure to rising damp.

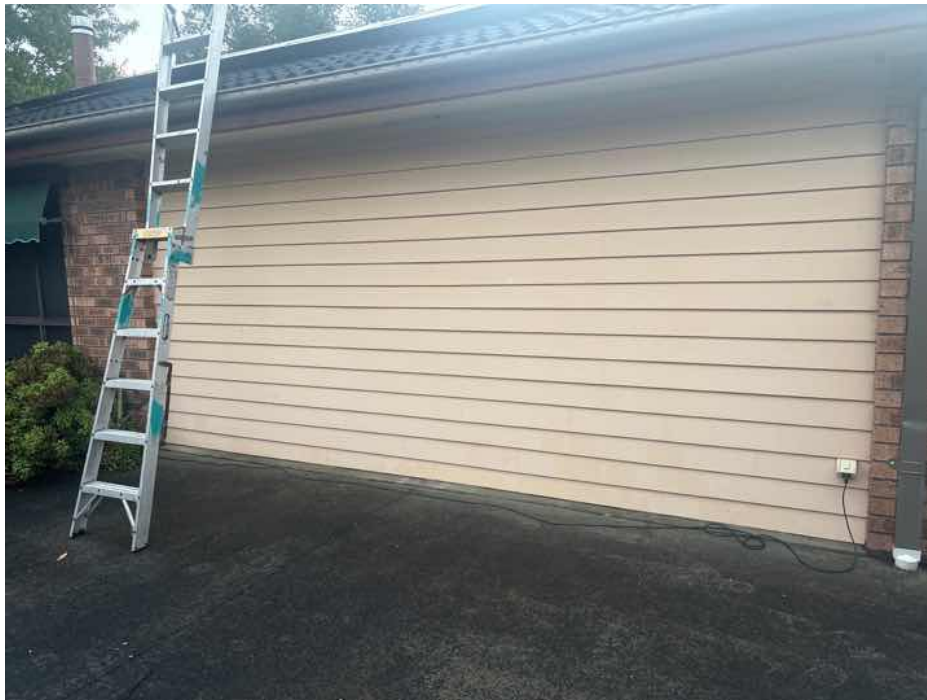
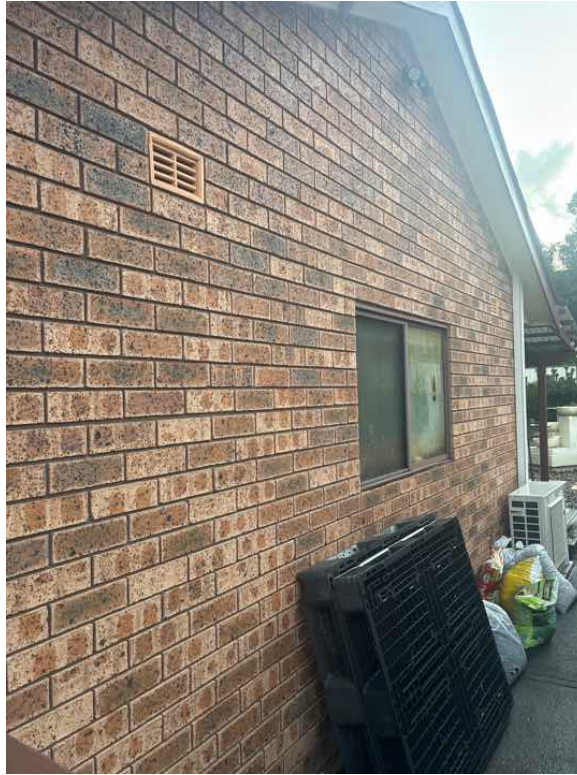
On visual inspection, the general condition of the exterior walls is serviceable for the age.

External cladding is in contact with the ground. This is a conducive condition for moisture penetration causing decay and/or concealed termite entry. Contact a licensed builder for recommendations.

Poor installation of cladding work noted. Incorrect installation methods have been noted for specific board type.

Rising damp detected. A qualified damp proof specialist should be engaged for advice and recommendations. Accurate diagnosis of the cause and extent of the damp problem is very important. It is strongly advised that you have this issue assessed prior to purchasing the dwelling as can be quite costly if a damp proof course has to be reinstated.

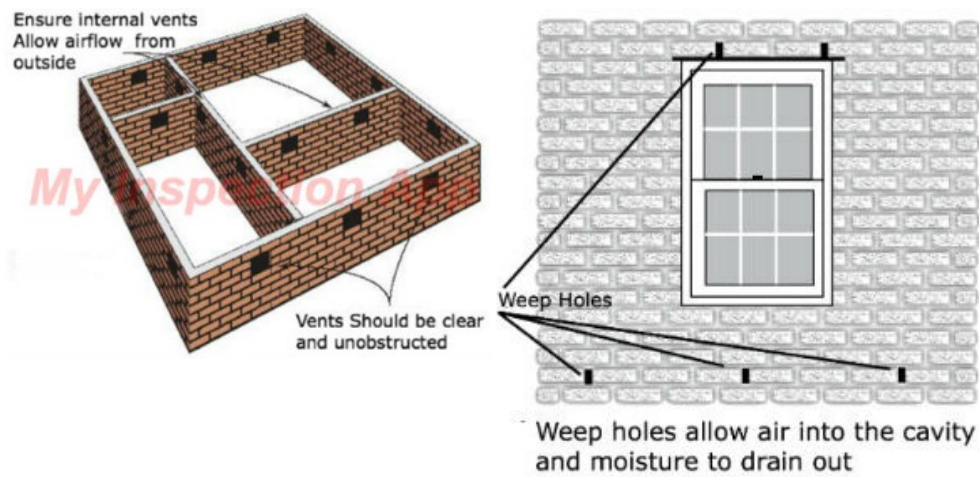
The vents are unobstructed.

Vents are covered by decks. Sub floor vents should be exposed and allowing free flowing air.

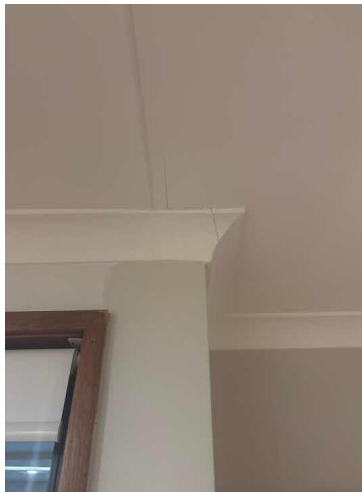
General ageing and/or denting and the like is evident on ceiling linings - Recommendations: A qualified painter should be engaged to assess and repair as required.

Ceiling join crack patching is evident. I recommend you contact a qualified painter for further advice and recommendations.

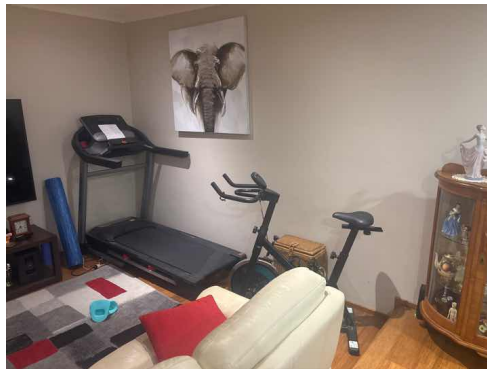
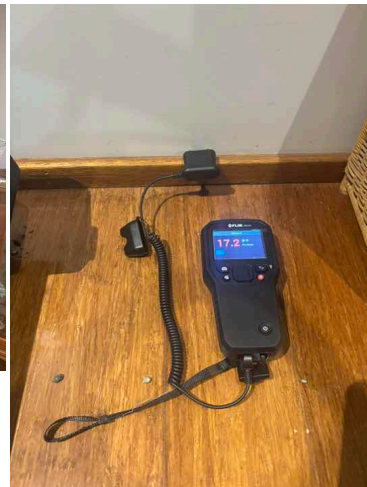
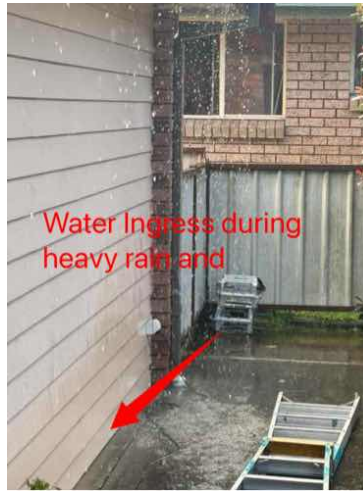
General ageing and/or denting and the like is evident on wall linings - Recommendations: A qualified painter should be engaged to assess and repair as required.

High moisture levels detected indicating rising damp. there can be other causes such as water ponding against the wall or poor drainage in that particular area. Rising damp in one area of the dwelling may mean that other sections of the dwelling may be affected and not yet visible. Contact a specialist in this field for repairs and advice. We recommend getting a quote prior to a decision to purchase as this can be very expensive to rectify.

Using an invasive moisture reading, results showed that the dry wall had over 17% of moisture. This indicates that water is penetrating the wall system from outside.

Further investigations suggests incorrect flashings have been used to seal the wall framing to the concrete slab.

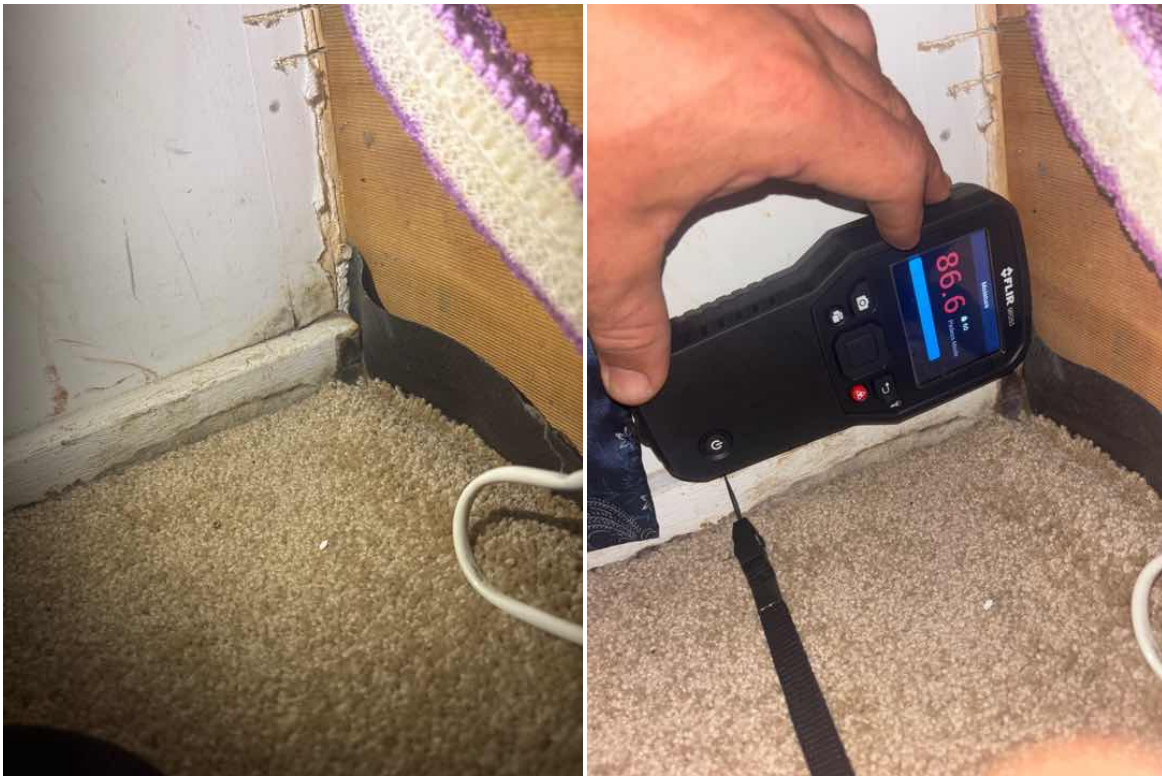
Excess moisture readings were obtained on the wall linings adjacent bathroom/shower. This may be related to the shower recess/plumbing in wall cavity leaking or failed waterproofing membrane to the wet area. Engage a plumber and a qualified waterproofing contractor for advice and recommendations.

Readings over 70 (pinless moisture meter reading) indicate a high level of moisture.

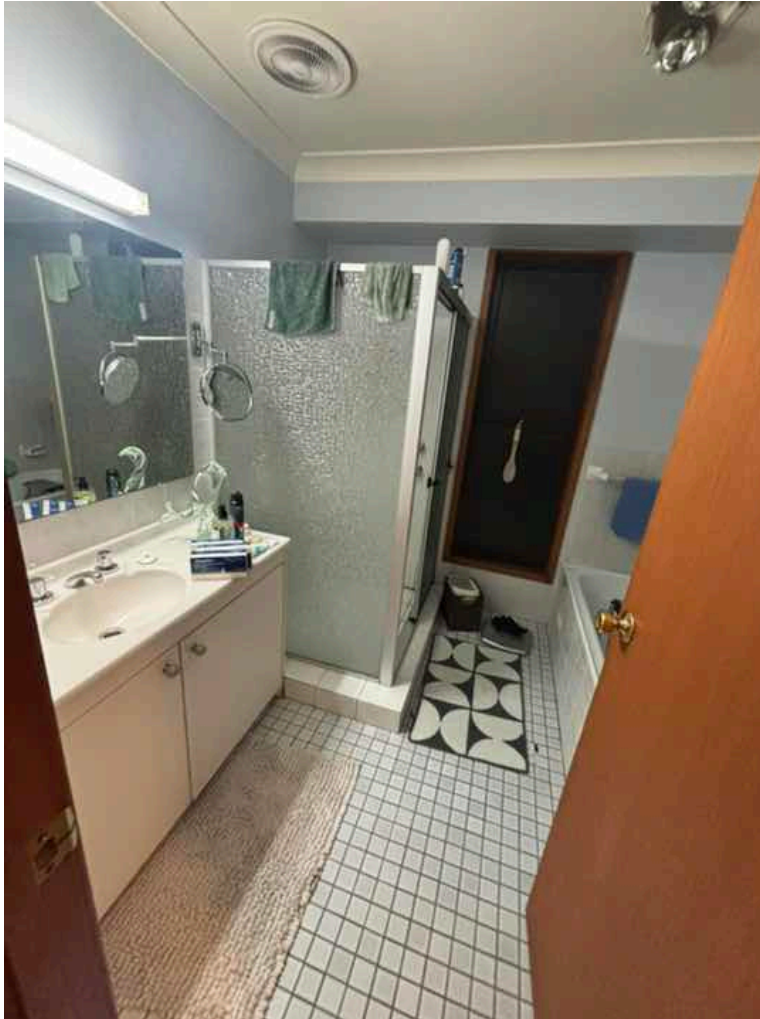
This bathroom is located in the hallway.

Of the visible areas, the general condition of this bathroom is serviceable or in reasonable condition for age of dwelling.

General deterioration and wear to vanity, cupboards and benches. Replacement recommended.

The vanity mirror is desilvering at edges. Replacement recommended.

The bath tub is deteriorate. Refinish or replace. Contact a qualified plumber for recommendations and repairs

Silicone sealant has been applied to the interface of the floor and walls in the shower recess in an apparent attempt to prevent water penetration to surrounding areas. This method of repair can only be considered to be temporary. Further waterproofing may be necessary.

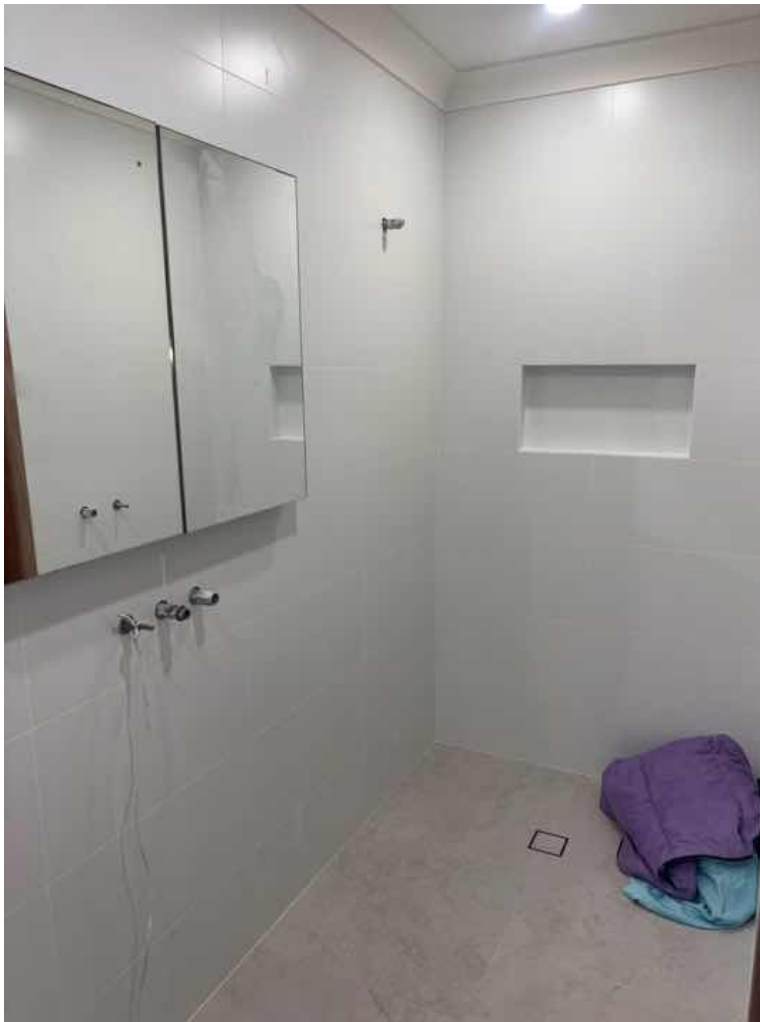
This bathroom is located in the master bedroom.

As this Bathroom appears to have been recently renovated, I strongly recommended you obtain the waterproofing certificates prior to settlement.

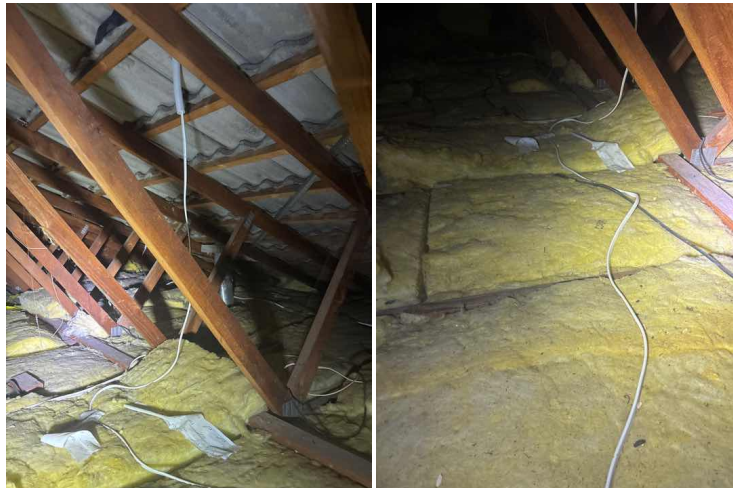
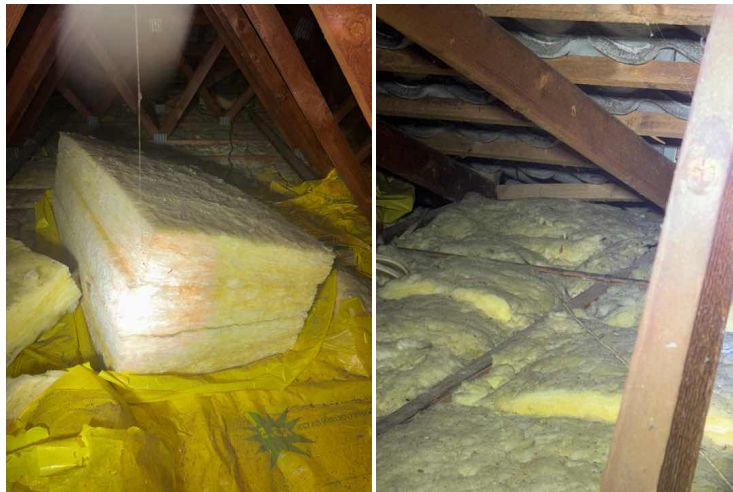
Visible sections of the roof void is in a serviceable condition for age of this dwelling.

Deteriorated batons observed. A qualified carpenter should be engaged for advice and recommendations.

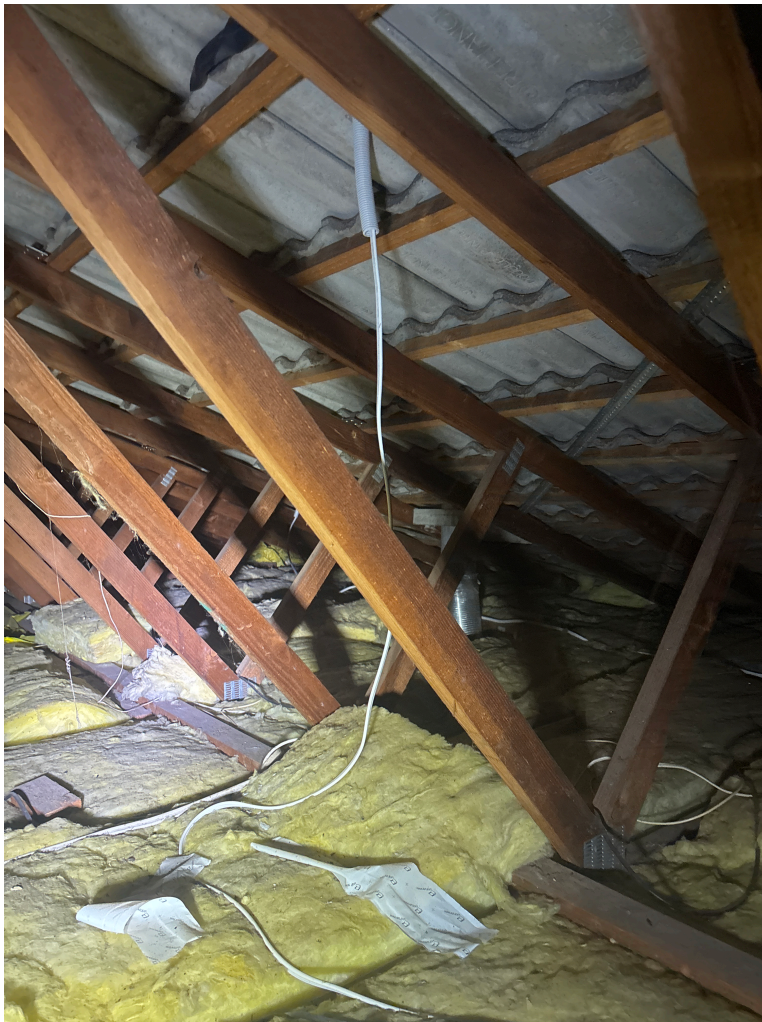
sarking is not Installed.

Sarking, a flexible membrane positioned beneath roof tiles, functions as a shielding layer akin to a second skin. Enhancing insulation efficiency, it safeguards against elements such as storm-driven rain (Leaks), dust, condensation, and embers during bushfires.
